Prepared for the Wheatley River
Improvement Group by

FIELD CREW SUPERVISORS REPORT

Summer 2014

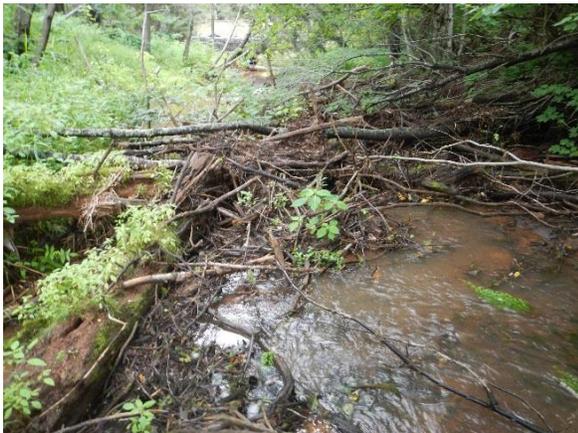
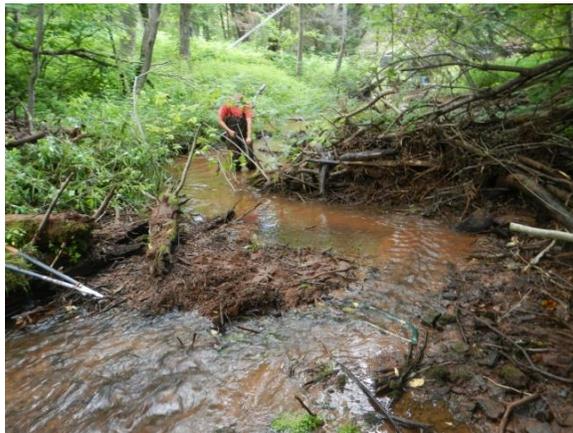
Figure 3 & Figure 4. An example of stream restoration: before and after pictures taken of stream cleaning on Parker Cross Road. There was immediate improvement to stream flow, and movement of sediment from stream bottom.

performed stream restoration techniques to improve fish passage and water flow. Our goal for this summer was to continue with the previous years' work and to try and get to as many of the streams that were missed and not previously assessed as possible. We found many sections that had not been looked at in a while had a lot of debris and blockages. Blockages for the most part were branches, leaves and silt that had been caught up on low lying branches during high water events

in the spring, contributing to entire fallen trees fallen during the winter or storms, spanning across the streams creating major blockages. Often, these blockages could only be removed by means of a chainsaw and heavy lifting. We removed these fallen trees in several locations in the watershed with the assistance of Jeff Arsenault (WRIG Chair) who offered his chainsaw and help to us. The places we removed trees were at Harvé Poiriers' property off the Winsloe Road (removed two there), on Stewart MacRaes' property off the Millboro Road (removed one there) and on Woltens (PID# 545616 off of Route 2).

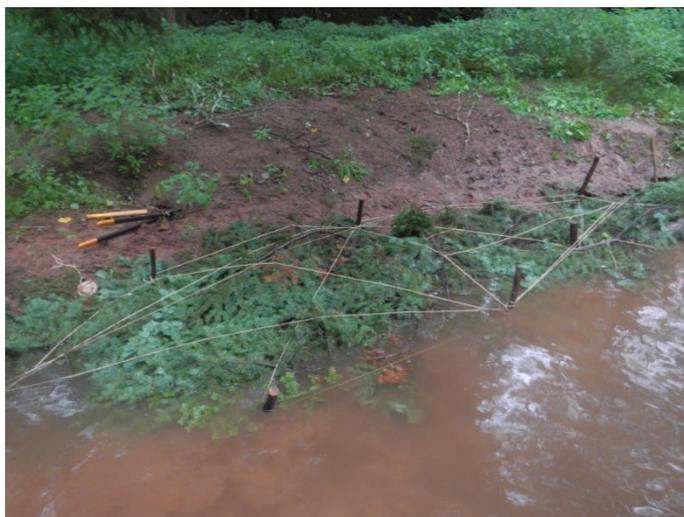
Figure 5. Brush mat made of spruce boughs and anchored with alder stakes and twine, Millboro Road.

Brush mats are a very important tool watershed groups have at their disposal. These in stream structures work to remove sediment from the water column, relocating it to the inside bends of streams and building up and stabilizing stream banks to prevent further erosion. While assessing the streams, when we found a good location to build a brush mat, we would mark it in the GPS so we could come back to that spot at a later time and construct it, enabling us to find the absolute best spots in that specific system the brush mats would be the most useful. In total, 8 brush mats were constructed throughout

the watershed this season. Brush mat locations can be seen on the map attached in Appendix I. Time was taken to assess brush mats that were installed by previous field crews, and there was good

evidence that they were still working well with vegetation growing on them and there was no work that needed to be done to them.

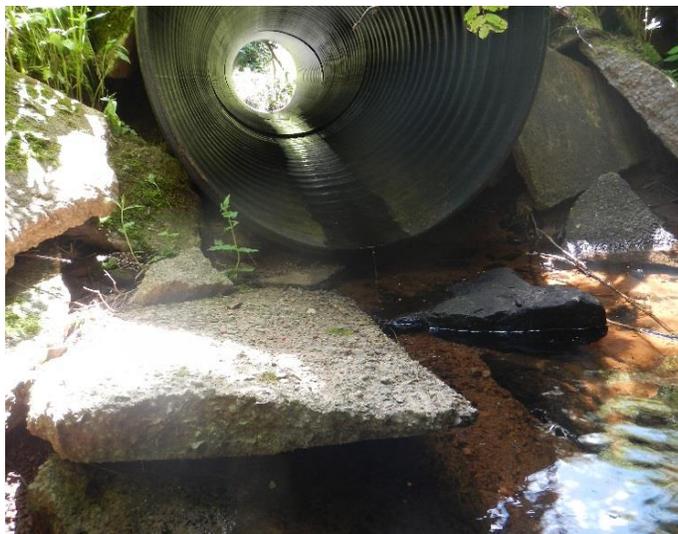
Figure 6. Hung culvert with low flow, an obvious barrier to fish passage.

stop working because they fill up with silt and overflow. Whenever these roads cross a stream is another place where runoff can enter the stream, and unfortunately in this watershed the dirt road stream crossings are not ideal. These crossings are major sources of fish passage problems in the Wheatley River Watershed. Many culverts are situated above the stream bed, often above the normal water level on the downstream side, a situation referred to as a hung culvert. As far as major barriers to fish passage in the Wheatley River Watershed, these hung culverts represent the majority of existing problem spots for fish, because they cannot

make it up past the culvert to get upstream.

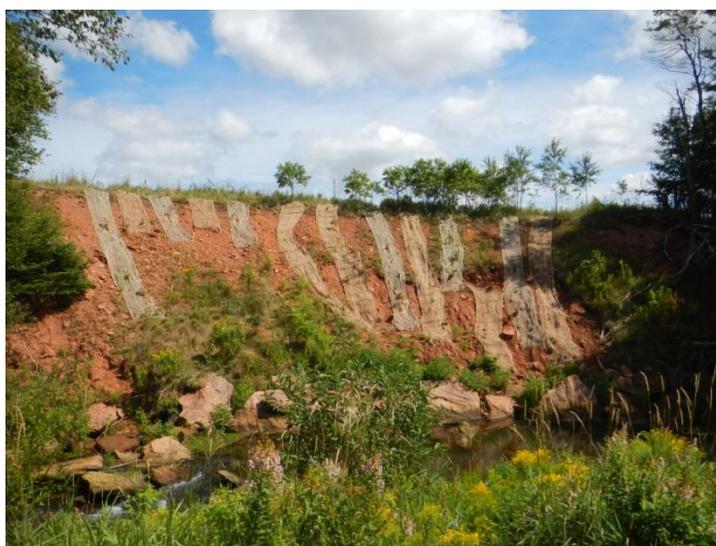
Rackham's Pond was the place for many different community events and field projects in 2014. This year we tackled the issue of the eroding cliff on the slope of the fish way leaving the pond. Over the past few years, the slope has been affected by heavy rains and snow melt every spring and the top soil is spilling into the river. In an attempt to prevent this from continuing, jute netting (a landscape netting donated by the PEI Dept of TIR) that will biodegrade in 3-5 years with no impact to the environment was used. We

Figure 7. Jute matting installed to reduce erosion on the slope below Rackham's Pond, and encourage plant growth.

placed the jute netting in strips vertically along the slope face, anchoring them with stakes and planted different species of stabilizing shrubs in and around the jute to also help roots and other vegetation grow and prevent future runoff. This was done in two phases, early and late summer, to make sure that the anchoring would work and that heavy rains wouldn't knock the jute down. By the end of the summer, they were still holding and the plants that had been planted were still doing well.
