Field Crew Supervisors Report 2016

PREPARED FOR THE WHEATLEY RIVER IMPROVEMENT GROUP

Brittany Maclean, Field Crew Supervisor

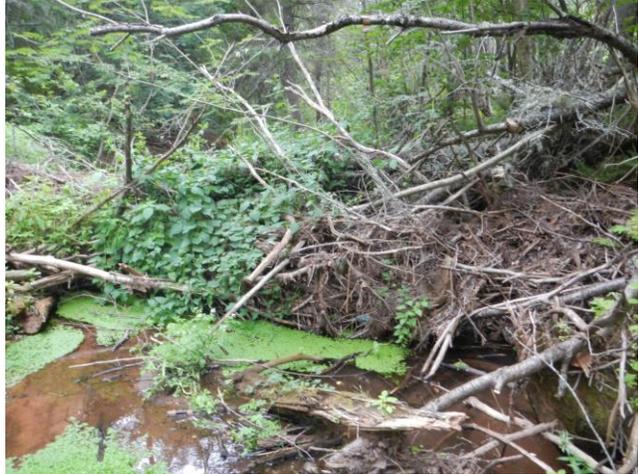
Figure 4 Blockage impeding Fish Passage Through the Little Bungay Branch Before

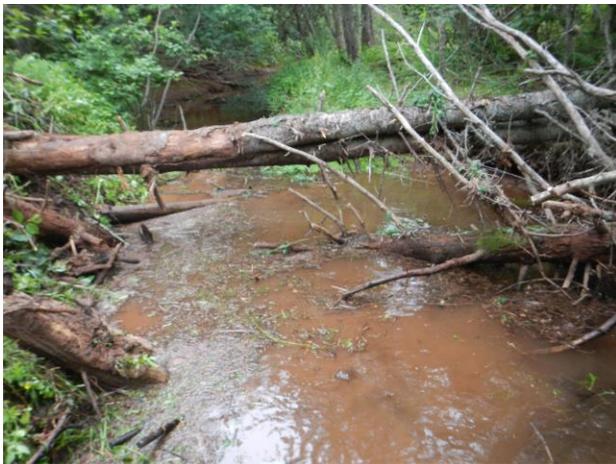
Figure 5 Blockage Impeding Fish Passage Through the Little Bungay Branch After

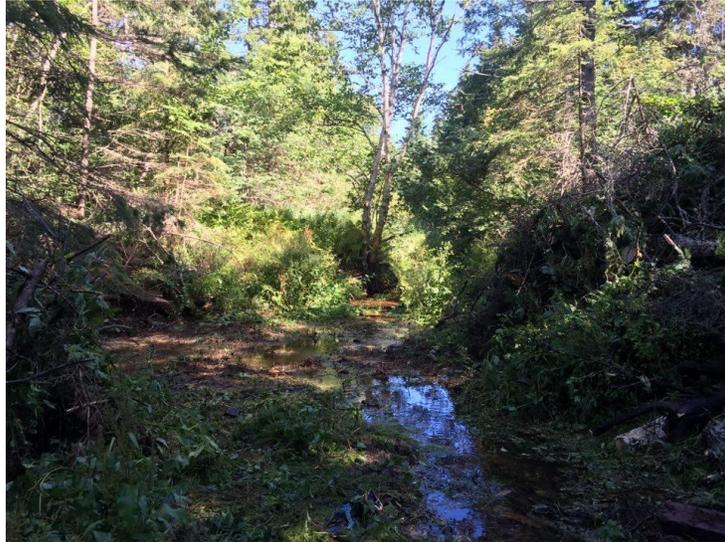
other competing plants from growing and establishing themselves. Brush mats would not have worked in this area because the alder density was too thick, so a patch of alders was removed completely, at an area of 30m² to make room for native species of plants to be planted and grow for better bank stability and erosion protection. While performing stream work the field crew came across several fallen trees in a row that were too large to remove, these trees fell over the winter and spring and since have blocked fish passage to spawning areas and collected debris that floated down the river. In total there was 4 trees in this one blockage, after being cut away and removed from the water stream flow improved immediately.

Figure 6 Chainsaw Blockage on Little Bungay Branch After

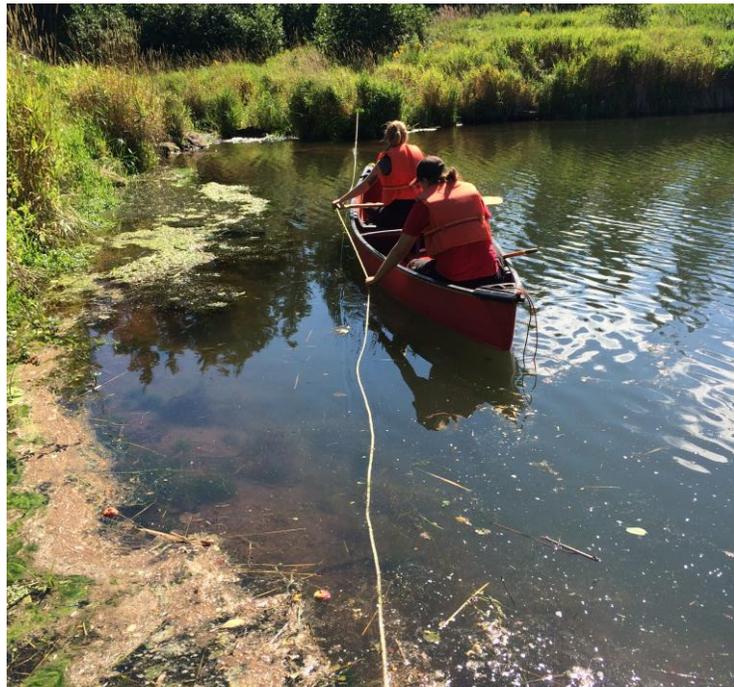
Figure 7 Rackham's Pond Depth Survey Transect Line 1, 2016

Rackham's pond, along with most PEI waterways, has had a lot of problems with silt and sediment build up over the year, in 2009 the pond was dredged using an excavator to help build up the banks using the silt removed and improve fish habitat and passage through the Wheatley River. The pond was dredged 10ft and the grand opening was June 26, 2010. Since then has been gradually filling in with silt again at increasing rate each year and has essentially become a silt trap. One project this year for the pond was a depth survey; by performing this survey we will get a better idea how much sediment has actually built up over the years and by doing this survey every year and gathering data we will be able to spot trends and have a better understanding and idea of what the best plan of action for Rackham's pond will be. To start we measured the length of the pond which was 184m, we then divided that into 10 transects that we measured our depths from. Each transect was spaced 20m apart from one another and we used rope as the transect indicator, it was marked with tape every 5m and that would be the specific point where we took the depth of the water. What we found was the pond was not as deep as we predicted, the silt has accumulated significantly in just 6 years and has even risen above the water in a section that can be seen in table 2. This has created a very large sand bar, cutting off access to one of the channels to the upper portions of the river.
