Field Assessment Report:  
Summer of 2011

Assessor: Christine McLauchlan

September, 2011

In association with the Hunter-Clyde Watershed Group and  
the Wheatley River Improvement Group

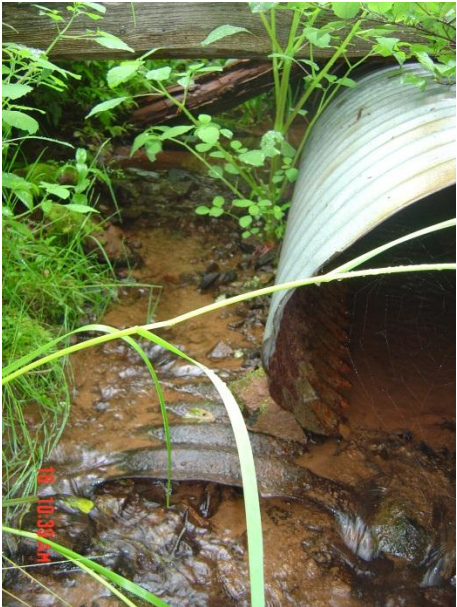
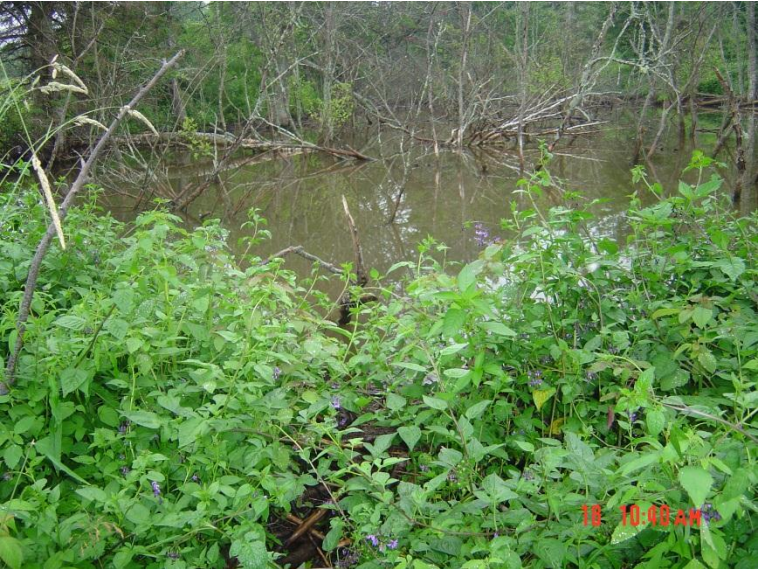
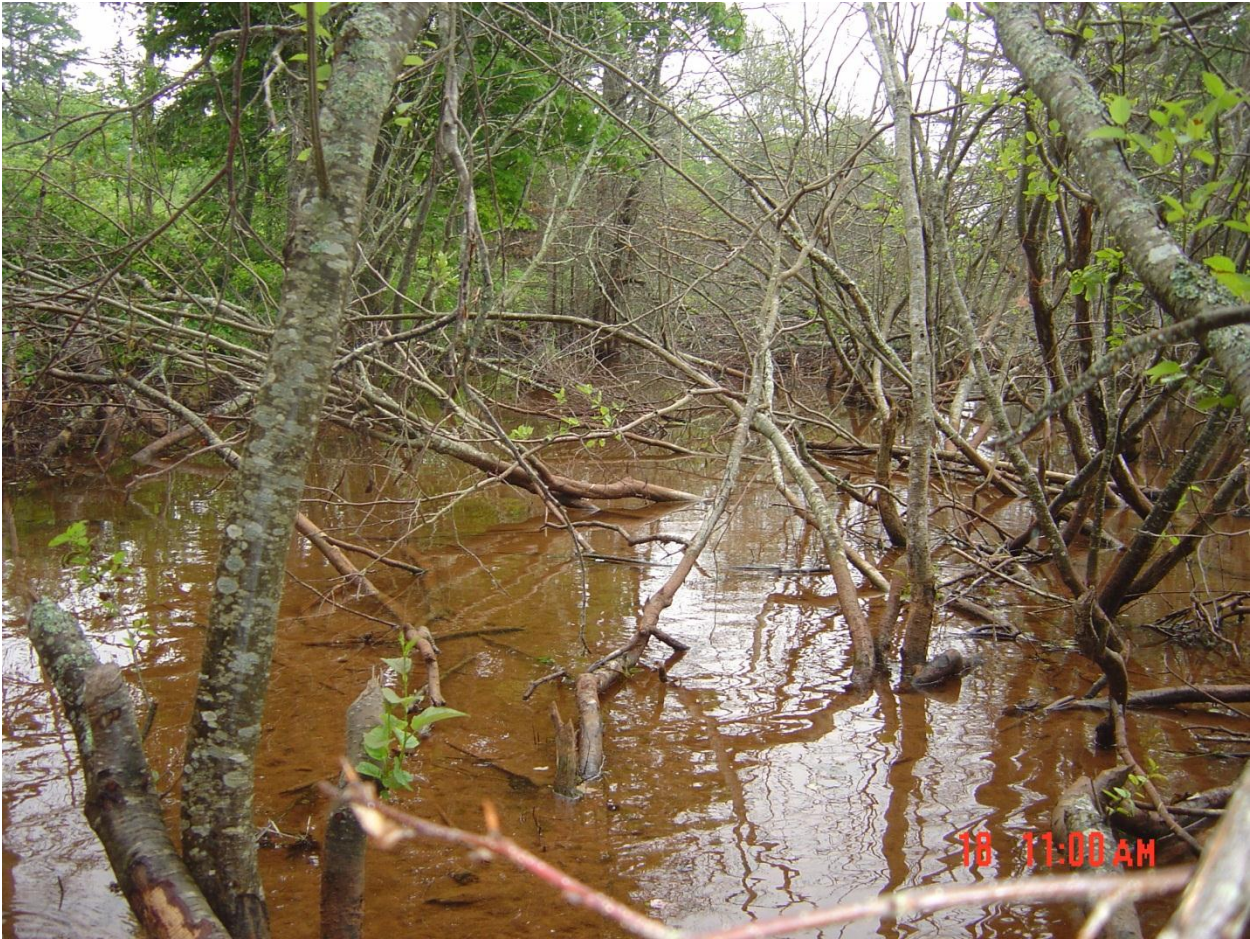
Waypoint 65:

Waypoint	Location	Score	$\Delta$ Velocity	X-ing Length	Notes
65	Rennies Rd	1	1	5	Beavers built around culvert (pond). Possibility of another culvert under the visible culvert.
14 (2)	Snowie Rd	4	-0.75	6	Three small culverts beside each other, all three looked blocked off at the upstream end as water was trickling down through the top.
233	Rte 13	5	0.75	4	Water velocity is high, the culvert is hanging, and it is creating a deep onion.
15 (1)	Snowie Rd	6	0.75	10	
130	Rte 13	3	-0.1	5	
234	Rte 13	5	N/A	9	Large culvert, hanging slightly. There is a wide and deep onion formed downstream.
112	Rte 13	5	N/A	N/A	Large onion.
137	Rte 13	6	-0.8	15	Downstream of the culvert, there is an onion.
124	Rte 13	8	0	4	The crossing is rotting and collapsing (made of what looks like old railway tie wood).
102	Rte 13	11	0.8	35	Crossing with baffling (cement flat bottom).
62	North Rustico	9	0	10	
77	Estuary	11	0	100	
105	Rte 13	8.5	0	7

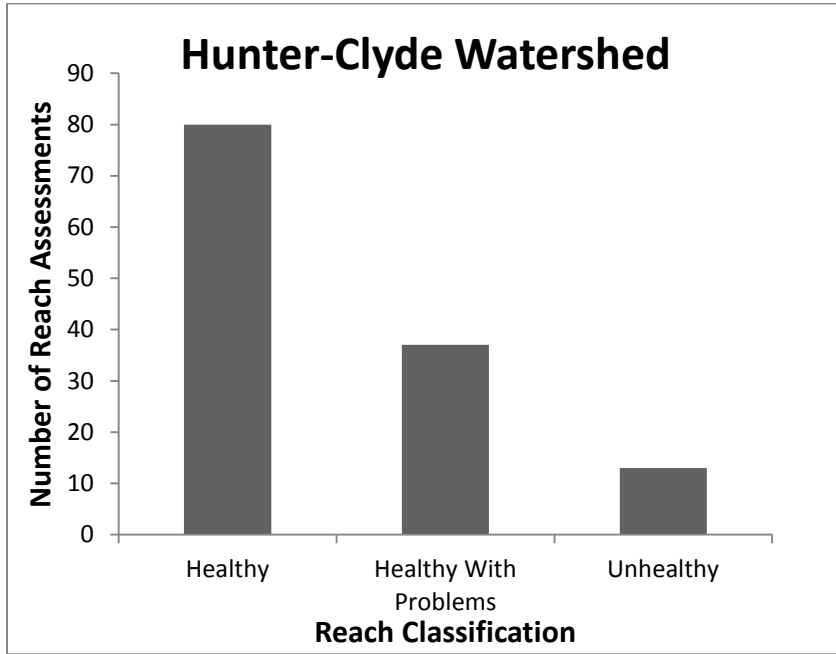
Figure 1: Classifications given to the various reaches assessed in the summer of 2011 in the Hunter-Clyde area.

In the Hunter-Clyde watershed, the main issues are also sedimentation and excessive alder growth. In general, however, the Hunter-Clyde watershed is quite healthy (with the exception of the 13 streams deemed 'unhealthy' in the results). Yew was found in both

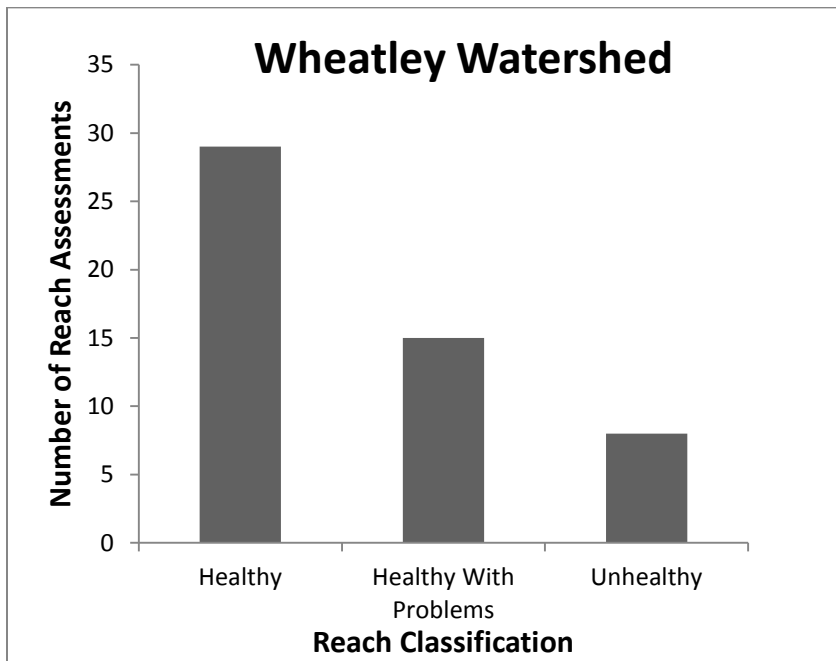
Figure 2: Classifications given to the various reaches assessed in the summer of 2011 in the Wheatley River area.

Streams in Wheatley River were most often crowded by excessive alder growth and sedimentation, making human passage extremely difficult. Anoxic puddles were also noted in Wheatley River, and interestingly enough, none were found in the Hunter-Clyde watershed in the 2011 assessments. Further studies for Wheatley River should include more water sampling, with a focus on dissolved oxygen, oxygen demands, nitrates and coliform counts. Coliform counts may indicate that the sources of pollution are of agricultural origin. The watershed group's current GIS software does not have land use maps for Wheatley River, and the future acquisition of these maps may help in understanding why oxygen levels are low. The assessment field sheet contains notes on each reach, and those highlighted in green are sites which would be good candidates for tree planting. In Wheatley River, I noted six sites that should be focused on in 2012 by summer work crews. Fish passage obstruction coordinates were also noted in the assessment field sheet.
