Field Crew Supervisor's Report 2020

Prepared for the Wheatley River Improvement Group

Tessa Craig, Field Crew Supervisor

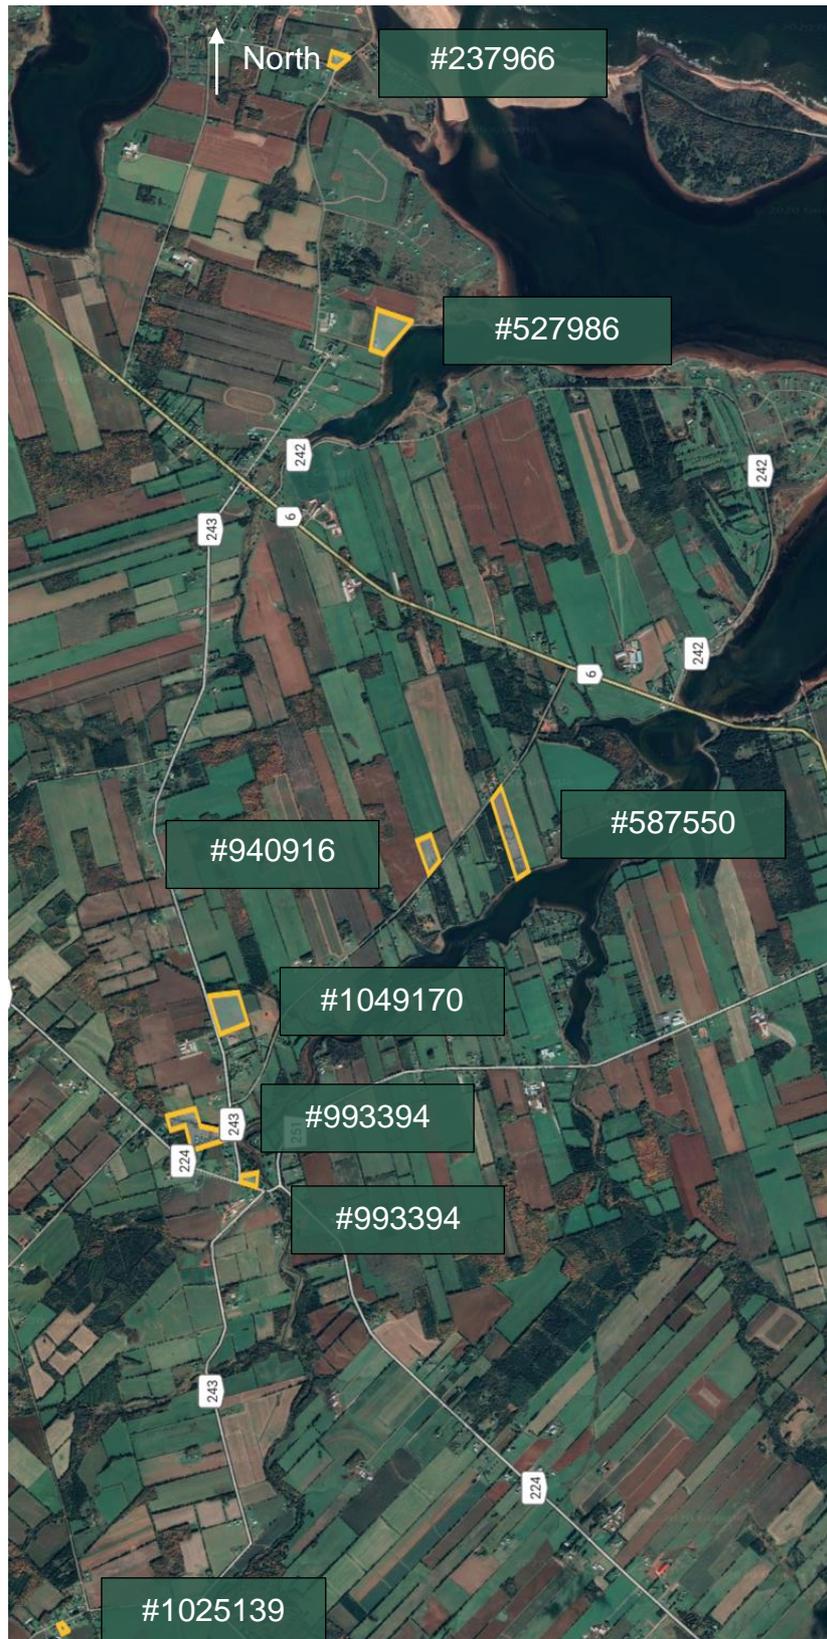
Figure 3. The eight private properties involved in the 2020 tree planting program. Created using Google Earth.

This summer, eight private properties were involved with WRIG's tree planting program (Figure 3). Twenty different native species were planted, for a total of 587 trees and shrubs (Table 1). The landowners approached WRIG with specific objectives, such as the naturalisation of former farmland, shoreline stabilization, creation of privacy and windbreak hedgerows, and attracting wildlife. Additional benefits include beautification, supporting wildlife, increasing biodiversity, and improved air, water, and soil quality². Hedgerows for privacy or wind protection also act as conservation corridors, providing food, habitat, and cover for wildlife⁶.

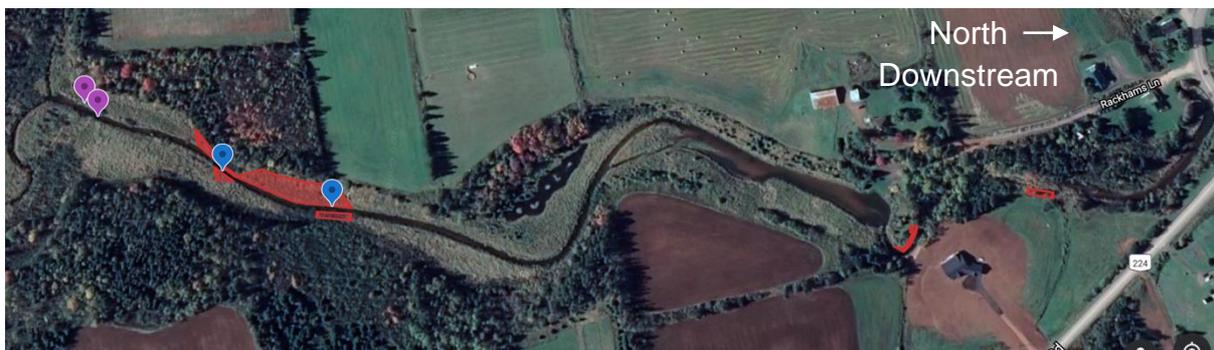
Figure 4. Stream restoration near Rackham's Pond including pinch flow deflectors (blue), brushmats (purple), and native species plantings (red).

Our efforts were focused near Rackham's Pond, alongside the main branch of the Wheatley River (Figure 4). We planted black spruce (5) and larch (5) just upstream from the Wheatley River bridge, in an artificially narrowed riparian zone lacking woody vegetation. We also planted shrubs on the exposed banks downstream from the Rackham's Pond outlet. Without vegetation cover, rainfall washes the bare soil into the stream. The erosion is exacerbated by the steepness of the cliff. Red-osier dogwood (8), mountain holly (4), and willow (4) were planted to help stabilize the steep bank. We would like to return to these two cliff sites in the spring to plant dogwood and willow cuttings. We also planted red osier dogwood (19), mountain holly (5), eastern larch (8), black spruce (7), white ash (5), and mountain ash (6) further upstream. Some of the dogwood, mountain holly, and mountain ash were planted near the new wing deflector to provide vegetative cover and accelerate the revegetation of the soil disturbed during the deflector build (Figure 5 and Figure 6).

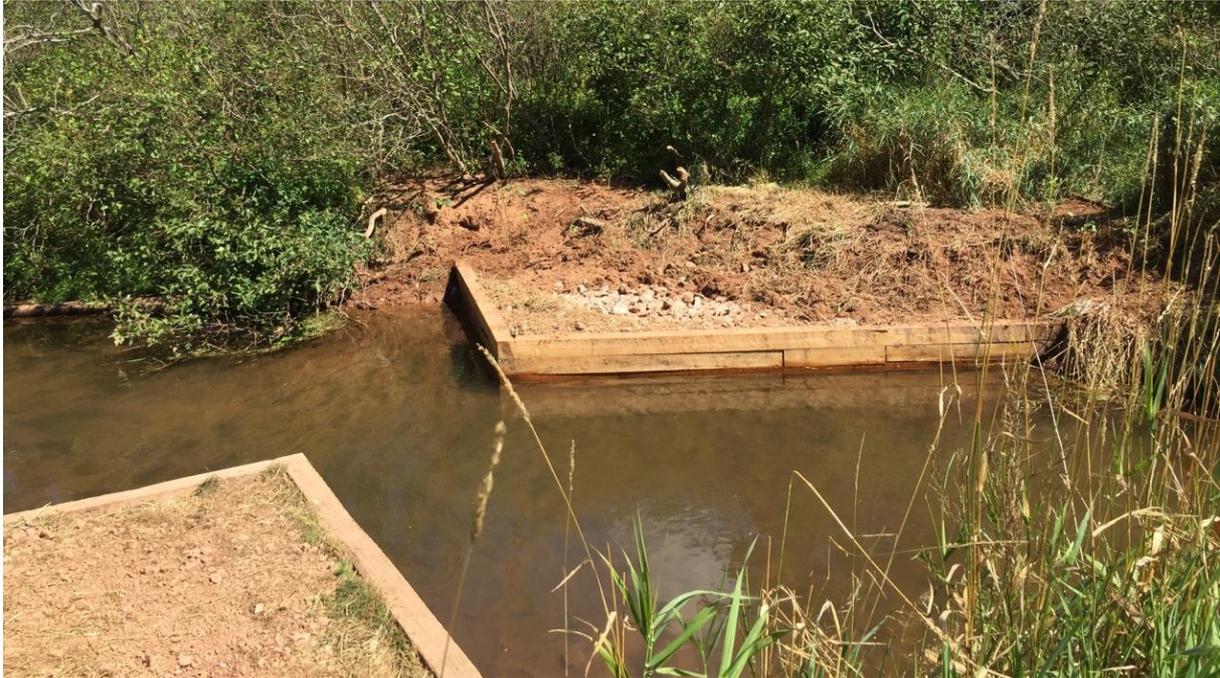
The new structure mirrors the downstream log crib wing deflector, “pinching” the stream (Figure 5). Narrowing the channel increases flow rate, which helps excavate sediment to create a scour pool for fish refuge. The walls of the structures are built from 6”x 6” juniper beams sourced from Betts Mills in O’Leary. Juniper, also known as larch or tamarack, is durable and naturally rot resistant: an important factor for a submerged structure¹⁰. The cribwork is attached with galvanized steel spikes (12”), keyed into the bank (3-4’), and anchored to the stream bottom with steel rebar. Five cubic yards of granite rock were used to back-fill the new deflector and armour the base.

Figure 5. The downstream 2017 (near) and 2020 (far) log crib deflectors.

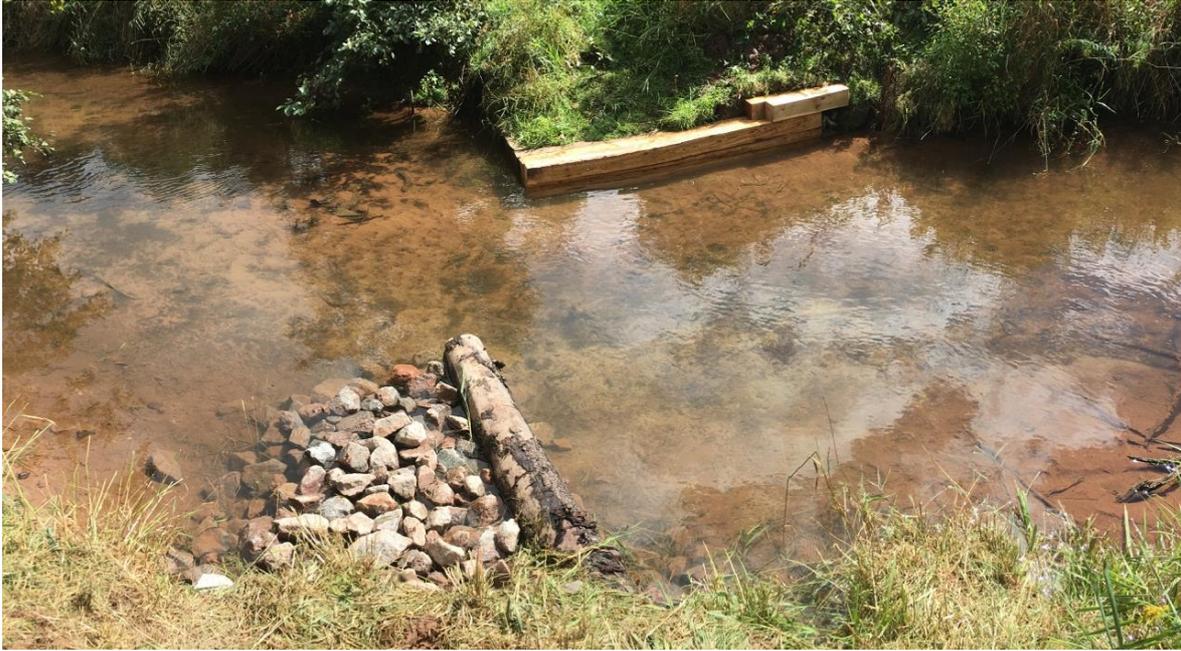
Undermining of the deflector point is a common long-term issue. Sediment had washed out from under the 2017 downstream log crib deflector and the rock fill hadn’t fallen to the substrate, resulting in a small cavity. This bypass reduces the deflector’s effectiveness, so we filled the cavity with extra rock and armoured the upstream base (Figure 5). The upstream log crib deflector was expanded two beam widths (i.e. one foot) on the upstream side. On the opposite bank, one cubic yard of granite rock was used to reinforce the log wing deflector, as there was little rock still in place from 2017 (Figure 6).

Figure 6. The upstream log wing (near) and log crib (far) deflectors built in 2017, pictured after the 2020 enhancements.

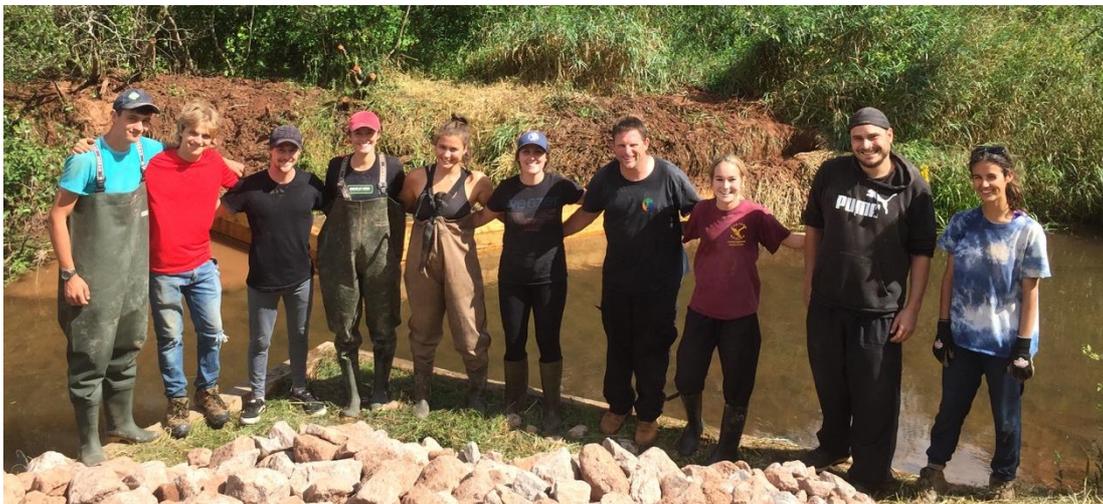
Figure 7. WRIG, HCWG, and BBEMA crews standing in front of the new log crib deflector. The deflector was filled with the granite rock shown in the foreground the following day.

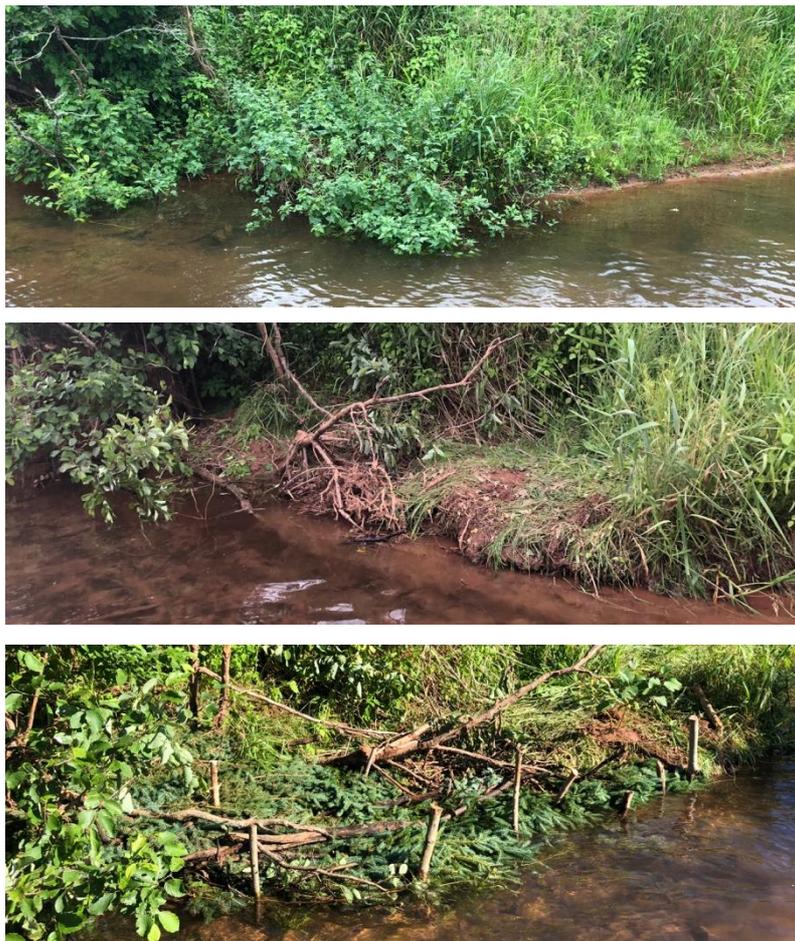
During the 2020 summer season, WRIG installed two brush mats on point bars upstream of Rackham's Pond. The first brush mat was constructed where the removal of bittersweet nightshade, an invasive species, had left exposed sediment (Figure 8). Red-osier dogwood was planted along the edge of the bank to provide vegetative cover and accelerate the encroachment process. The second site was recommended by Mary Finch and Rosie MacFarlane during the deflector consultation.

Figure 8. A cluster of bittersweet nightshade, an invasive species (top). Exposed sediment after the nightshade was removed (middle). The finished brush mat with dogwood plantings (bottom).

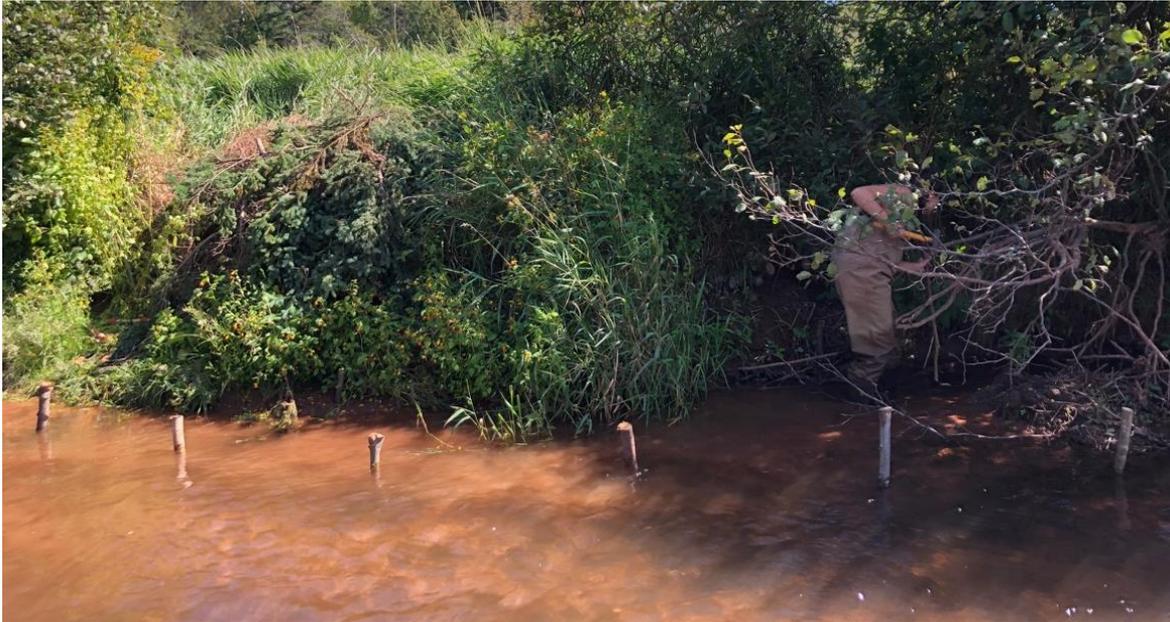
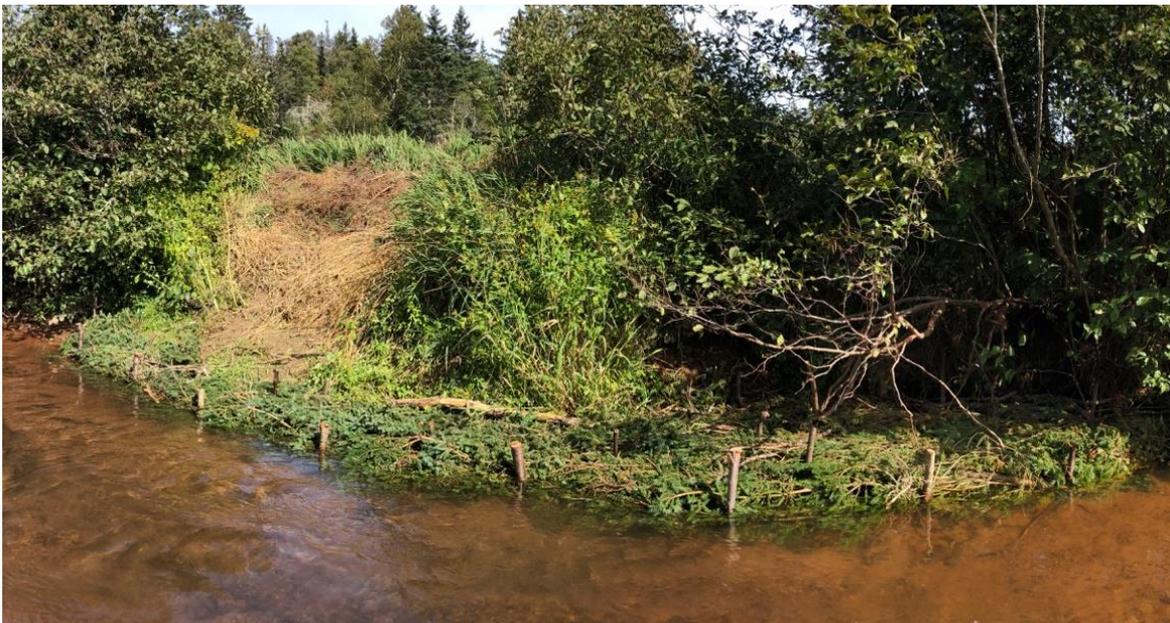
To improve the environmental footprint of the brush mats, we made stakes out of branches pruned from trees at Rackham's and other planting sites. The second, larger brush mat was constructed with conifer boughs donated by the Asplundh Tree Expert Company (Figure 9). Asplundh was contracted to prune trees along ditches on the Stead and Bungay Roads for utilities/government agencies. We were pleased to recycle the boughs, as it prevented the trimming of conifers near the stream. It was decided to use jute to secure the boughs to prevent plastic twine from becoming part of the bank. The brush mats are in a highly trafficked area so will be monitored regularly, with repairs being made as needed (Figure 4).

Figure 9. The second brush mat constructed during the 2020 field season.

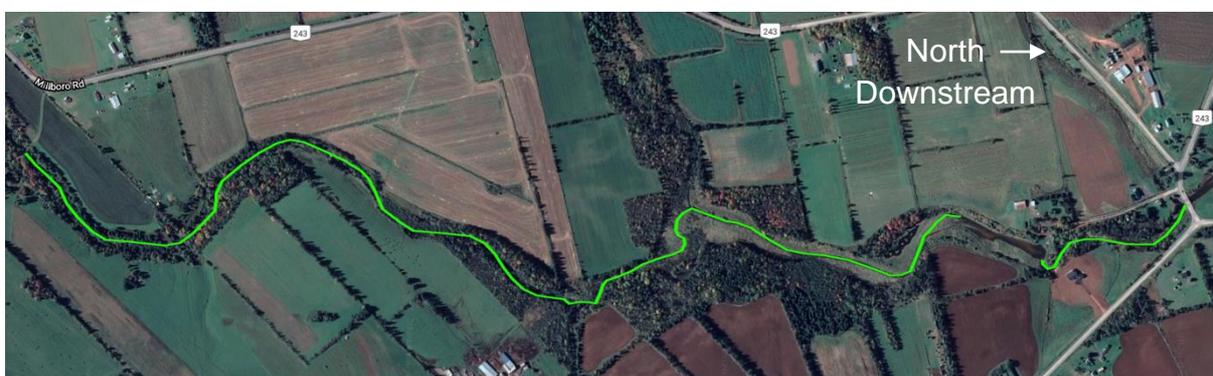
WRIG successfully completed the 2020 goals of clearing 3km of stream and assessing the health of the accompanying riparian zone. This summer, we focused on the main branch of the Wheatley River system, as this particular stretch had not been assessed since 2017. Beginning at the Wheatley River Bridge and walking upstream, we followed the main branch of the Wheatley River by continuing above Rackham’s Pond and going left at the forks (Figure 10).

Figure 10. Sections of the main branch of the Wheatley River where stream clearing and riparian health assessments occurred.

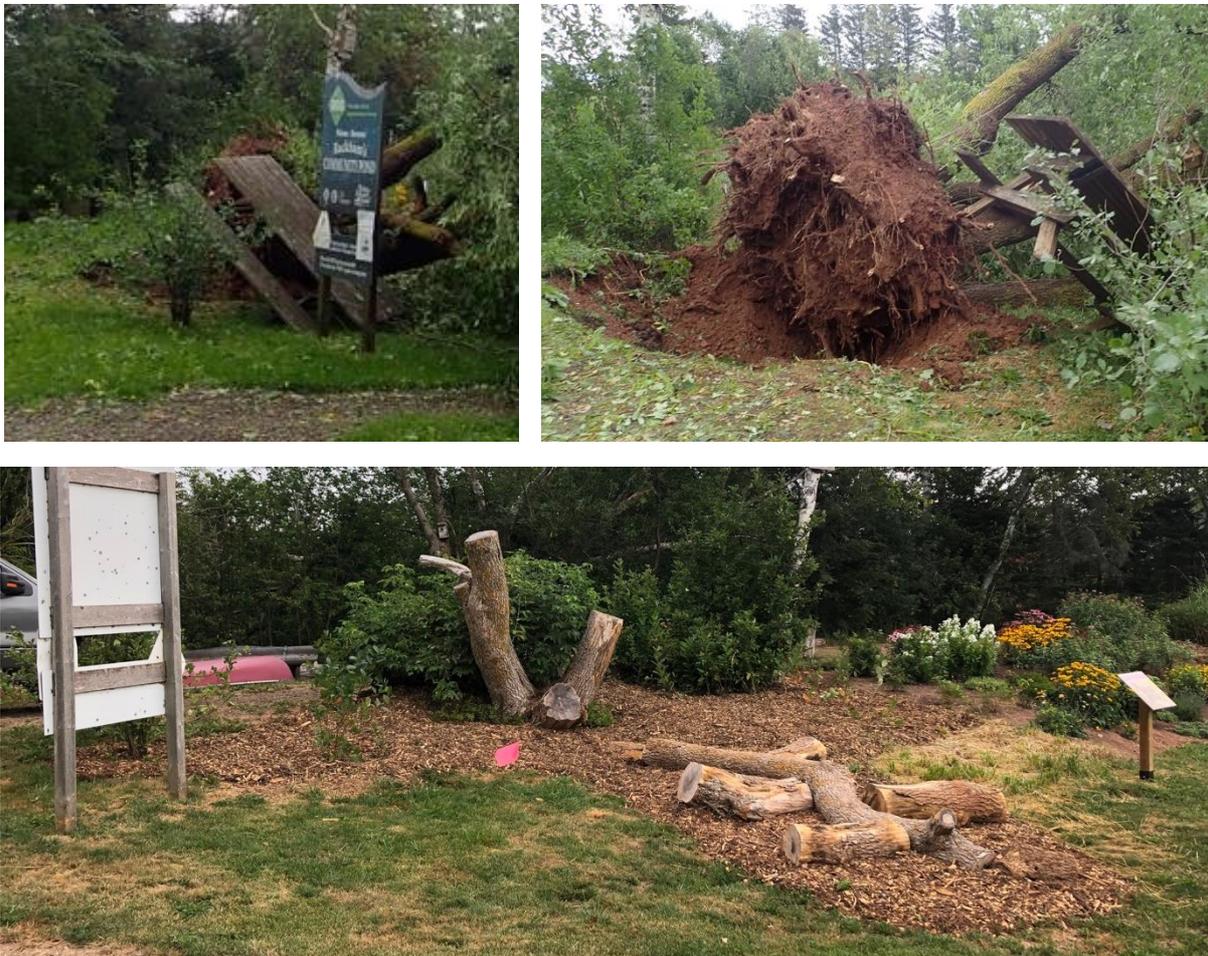
Figure 15. The fallen tree post hurricane Dorian (top) and after WRIG's hard work (bottom).

In the fall of 2019, Hurricane Dorian blew a large tree down in the Rackham's Pond park area. When the temperature warmed, community members kindly volunteered to limb the tree and block the trunk. When WRIG's summer staff began work, all that remained was the stump, some large sections of the trunk, and a trench filled with weeds. We decided to beautify the remnants of the fallen tree by turning it into a living playground and garden feature (Figure 15). Once "The Stump"

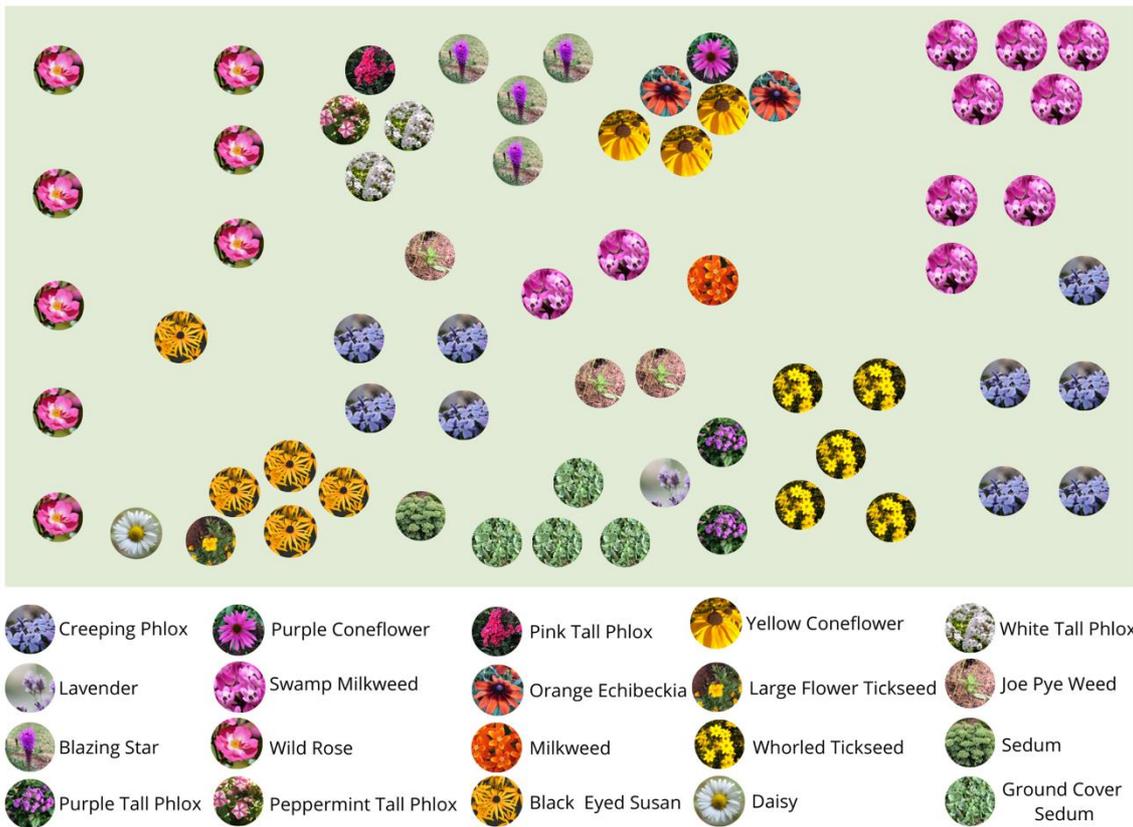
Figure 17. A map of the Rackham's Pond Educational Pollinator Garden

milkweed plants were thoughtfully donated by Denise Motard of Stratford. This milkweed, along with twelve more purchased from the provincial nursery, were planted in the garden. Joe Pye Weed (12) purchased from the nursery and Tall Phlox (4) donated by my mom were also added (Table 1). Regular watering by the WRIG crew helped the new plants establish and the garden flourish despite the hot, dry summer. A number of plants with staggered bloom times meant the pollinator garden was always buzzing with activity (Figure 16). This summer we also created a map of the pollinator garden to facilitate work by future staff (Figure 17).

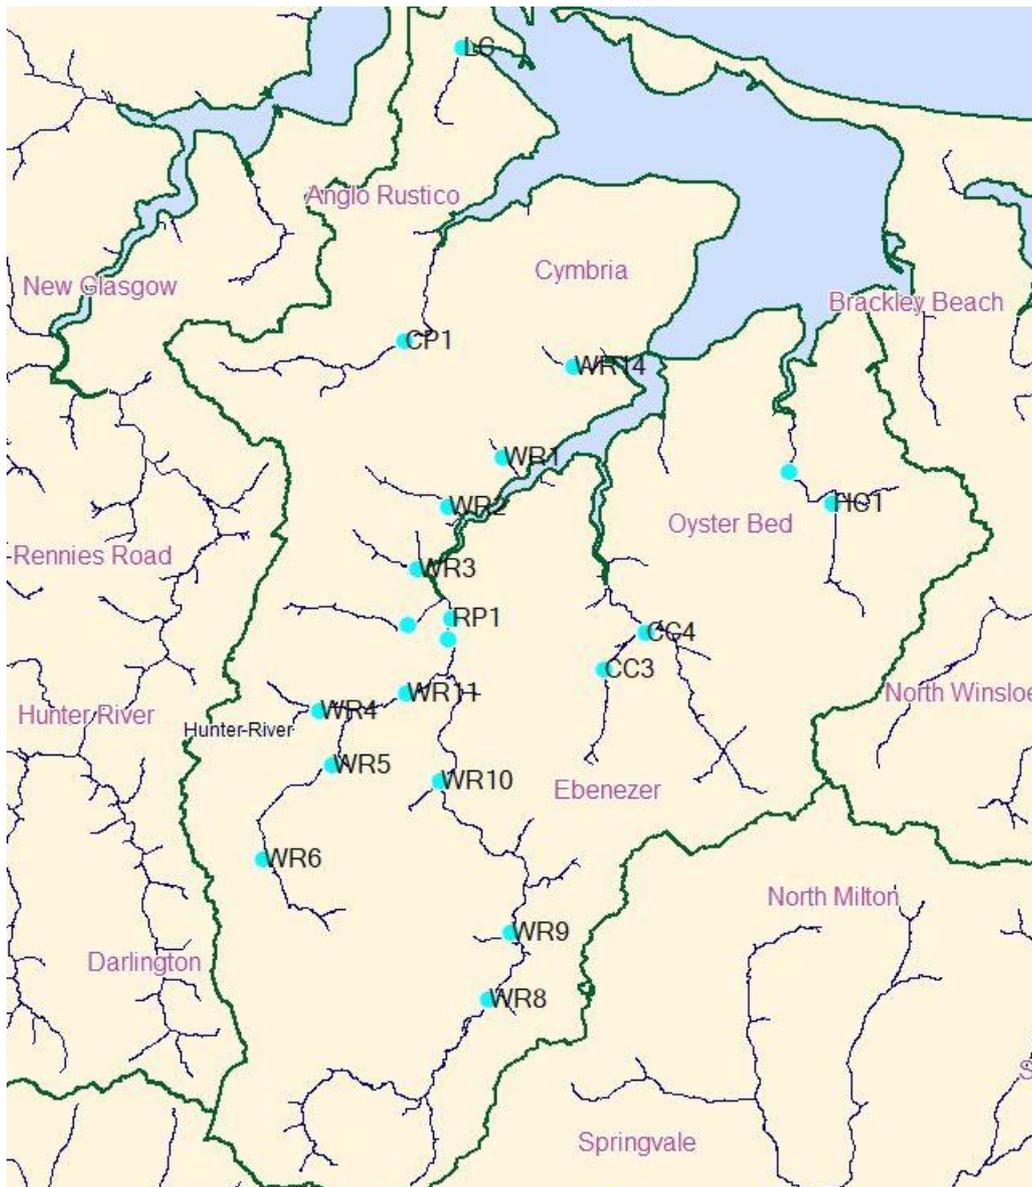
This season, some of the water quality monitoring sites were reassessed for pertinence. Two sites along Crooked Creek were removed from regular testing due to a consistent lack of water flow and an 11th testing site was added along the Wheatley River. Luke's Creek (1), Crooked Creek (2), Horne's Creek (2), and Chapel Creek (1) were also monitored. Low water levels were observed early in the work

Figure 18. A map of the 20 water quality monitoring sites tested weekly from June 15th to August 28th, 2020.

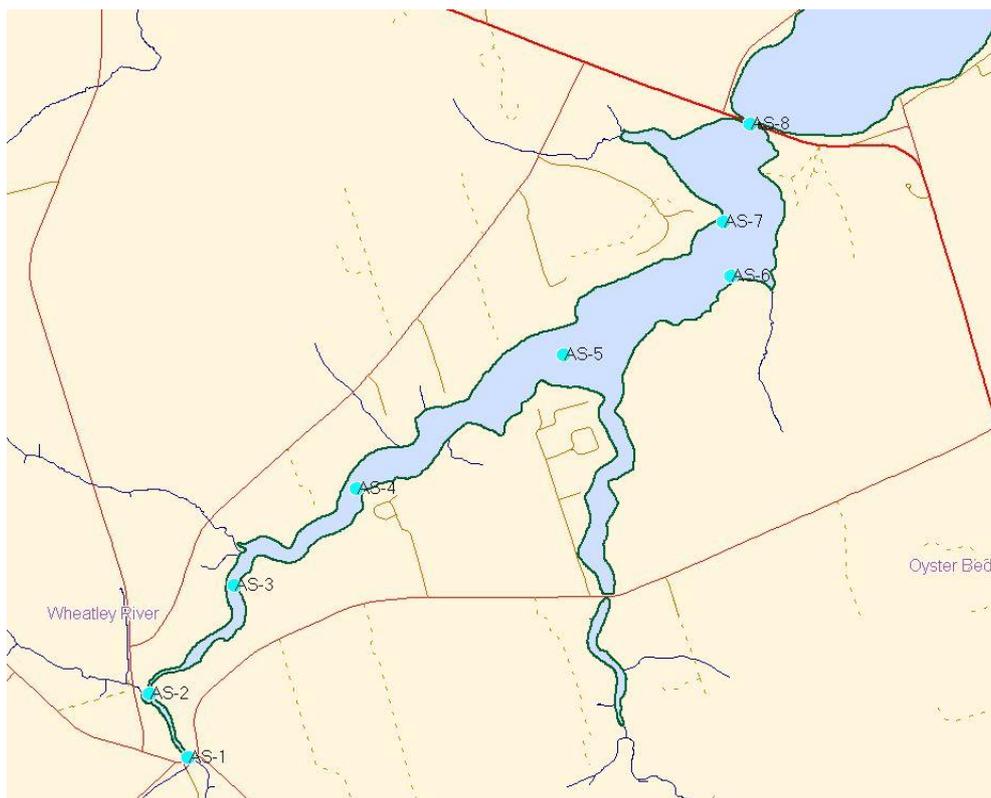
This summer, fifteen Island estuaries experienced anoxic events. The Wheatley River estuary turned anoxic in the beginning of July, earlier in the season than previous years¹⁷. WRIG staff conducted a monthly canoe survey of the Wheatley River estuary to monitor for signs of anoxia. Eight sites between Wheatley River and Oyster Bed Bridge were assessed using the qualitative survey from the citizen scientist anoxia tracker program (Figure 19). We recorded water clarity and colour, sea lettuce coverage and condition, and the strength of sulphuric odour. We also measured water temperature, dissolved oxygen, specific conductance, conductivity, total dissolved solids, salinity, and pH using a YSI borrowed from the PEI Watershed Alliance.

Figure 19. A map of the eight anoxia survey sites tested monthly from June to August, 2020.
