# Field Crew Supervisors Report 2017

Prepared for the Wheatley River Improvement Group

Brittany MacLean, Field Crew Supervisor

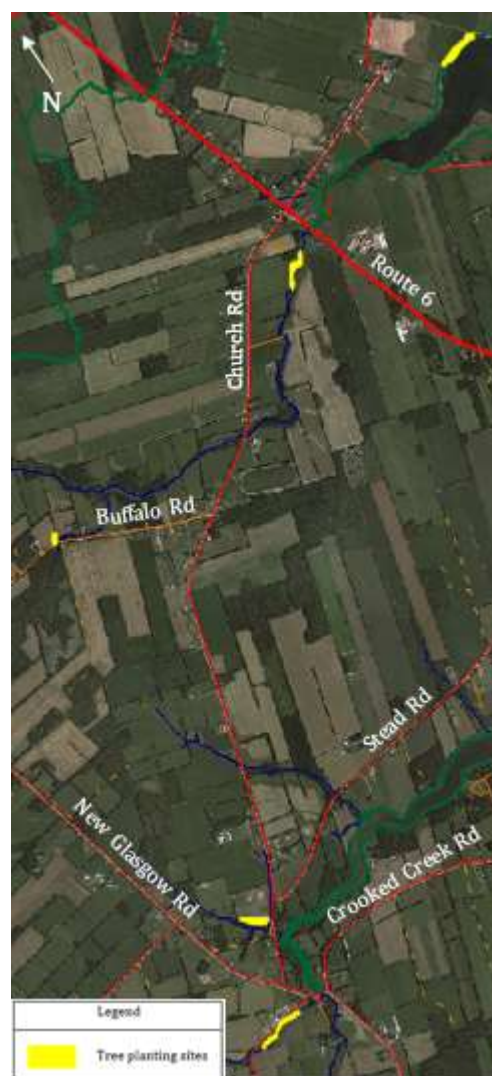
Figure 1: WRIG Tree Planting Locations for the 2017 Summer Season.

Trees were planted at this site the last 2 years, where some of them have begun to establish themselves. This area is a retired hay field with a seasonal drainage basin trough the center, emptying into a tributary off the Wheatley River. There was an additional 102 trees planted amongst the established ones at this site. The Fourth site was a tributary protection site off the Millboro Rd, Property #240481. This property is a recently retired cattle pasture, where the landowner approached WRIG to try and enhance and protect the Wheatley River tributary that runs through it. 24 very water tolerant species were planted here. The fifth site was a buffer zone enhancement site off the Church Rd, property #795864. The buffer zone on this property was mostly comprised of grasses and sporadic shrubs, with no diversity or deep root structures for bank stabilization and runoff mitigation. 80 tree and shrub species were planted at this site to help enhance the effectiveness of the buffer zone. Refer to figure 1 for all planting locations.

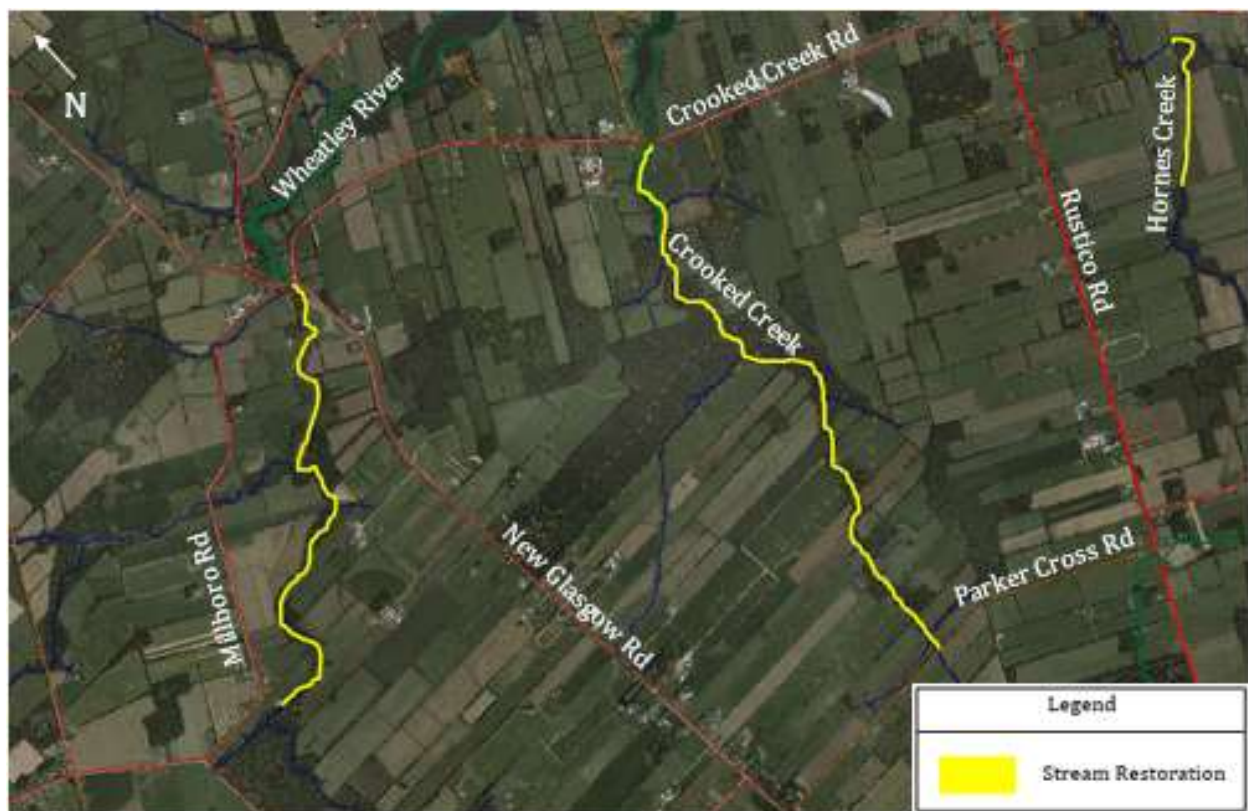
Figure 2: WRIG Stream Restoration Portions for the 2017 Summer Season.

This year WRIG has assessed and restored 6.01km of stream, to improve the overall health, native fish passage and spawning habitat throughout the system. Portions of 3 major systems were restored this year, seen in figure 2. Most of the effort was directed towards the Crooked creek main branch. Work started off the Crooked creek Rd, property #576587 and ending on the Parker Cross Rd, property #940361. The Crooked creek system was not

looked at by WRIG for multiple years. The first portion on property #576587 is still part of the estuary and is experiencing high erosion rates. The only bank stabilizing plant in that area are smooth cordgrass *Spartina alterniflora*, and other salt tolerant grasses. From property #241398 to property #992347 this portion had adequate buffer zones and late successional deep root trees surrounding and stabilizing the banks. Areas were over grown

by alders however. Property #992347 itself appeared to be an old beaver habitat with many blockages with excessive silt on the substrate. The banks of this beaver area were suffering from extensive erosion, to help mitigate the effects 6 brushmats were installed in this area, seen in figure 3, in an effort for fortify and build up the banks. From property #240846 to property #940361 the conditions remained consistent, the substrate had high amounts of silt with sporadic areas of cobble bottom, alders were heavily overgrown in areas providing very little bank stabilization and blockages, along with fallen trees. Property #240903 had several fallen trees over the stream system that require a chainsaw for removal. The second system that was restored was a portion of Hornes Creek, located on properties #241711 and #856153. The landowner contacted WRIG to assist in the removal of fallen trees in the stream on the property. There was a total of 3 trees that were removed. The rest of the portion of stream that was restored had very poor bank stabilization due to the lack of deep

rooting vegetation in the area, as a result the substrate was heavily silted. On Property #856153 this portion of the stream was overgrown by alders which were impeding stream flow and choking it out. The third system that was restored was the Wheatley River main branch, above and below Rackham's pond, starting off the New Glasgow Rd property #240614 and ending at property #240689 off the Millboro Rd. The portion above Rackham's pond, on property #240614 is restored annually in preparation for the celebrate our river even held on the last Saturday in August. There was very few blockages and the substrate was cobbled with little siltation in this section. The portion below Rackham's pond on property #1062900 to property #240689 has been restored by WRIG in the past, this time was to assess the health of the stream after the initial work. This portion of the Wheatley River had a rocky substrate and few recent blockages, the banks also had deep root vegetation for stability. There were two locations on this system however that no buffer zone is present between the agriculture field and the stream. Property #240671 have a livestock pasture fenced off at the edge of the river and large sections of the stream bank are eroding away where the fence was driven into the ground. Property #518225 have a spring fenced into the livestock field providing access for the animals to enter the spring, the path the livestock travels is starting to erode into the stream.

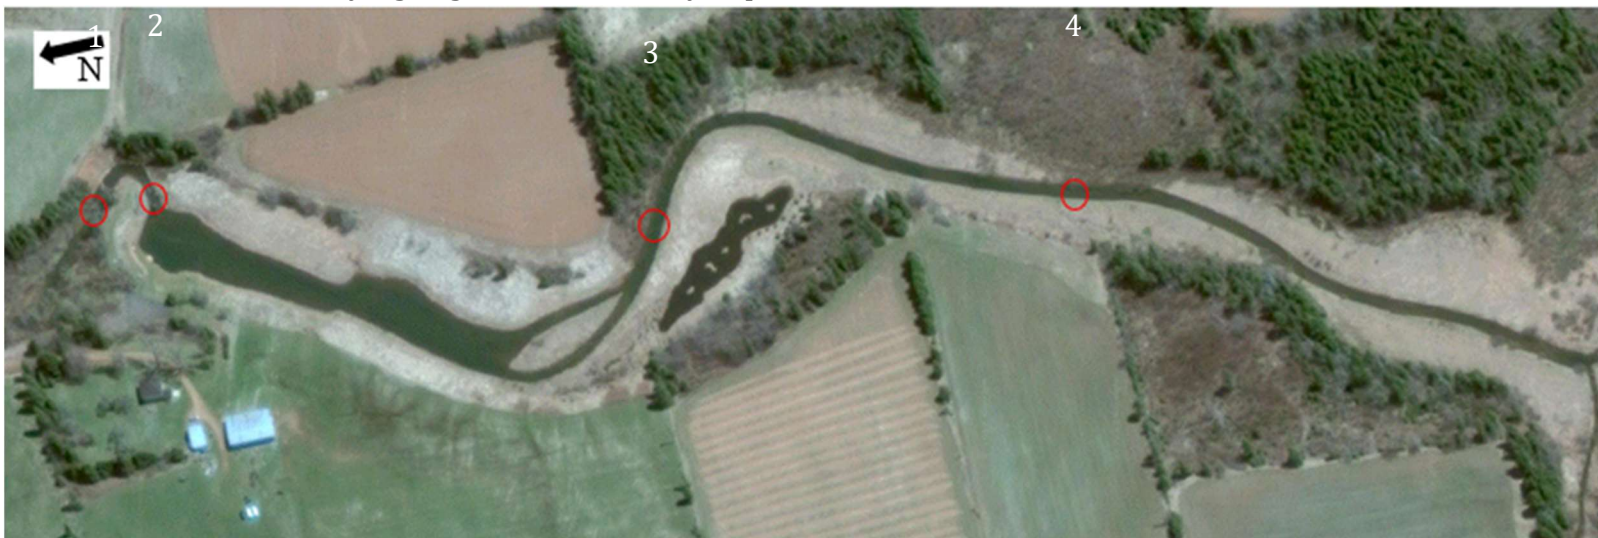
Figure 4: Macroinvertebrate Sampling Areas Along Rackham's Pond on the Wheatley River, Each Location one Hester-Dendy Sampler was Placed.

macroinvertebrates colonize different habitats of substrates. Rackham's pond is composed of two different substrates, hard and soft. Hard substrates are comprised mostly of cobble and hardbottom substances, and soft substrates are comprised of silt and sand bottom. It is important that the scope of the sampling encompasses both substrates present in the area. At Rackham's pond 4 different sampling sites were used, shown in figure 4, using a multi-plate Hester-Dendy sampler. Hester-Dendy's provide an opportunity for the invertebrates to colonize the sampler, and later be examined. The Hester-Dendy's were anchored to the bottom of the stream bed with rocks but not in direct contact with the substrate, with the plates parallel to water flow. The sampling took place from July 7-July 24, 2017. Referring to table 2 and 3, location 1 had more variety of species compared to 4 and 3, however most all species were tolerant and somewhat tolerant to pollutant in the water.

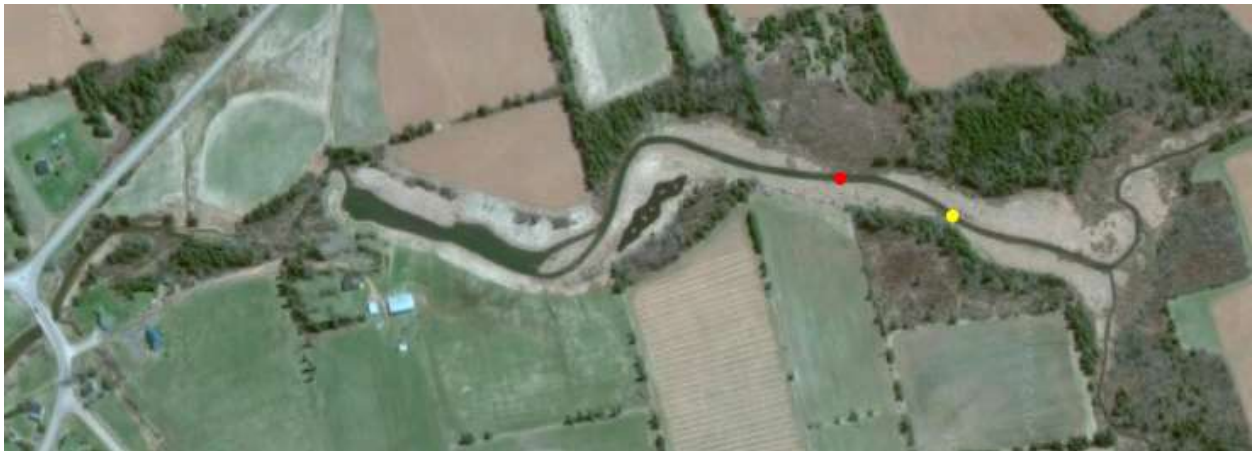
Figure 6: Aerial Photo of Rackham's Pond on the Wheatley River, 2017. The Red Marker Indicates Location of Log Crib Deflector, Yellow Marker Indicates Location of Pinching Deflector.

habitat for rearing and migration along with the displacement of some sediment buildup. Using access from property #1062900 the first deflector, indicated by the red marker in figure 6, was built using 4-16 ft 6x6 juniper beams and 4-12ft 6x6 beams, connecting at a 90° angle, 7ft from the banks and keyed into the bank 4ft. Juniper beams were used because the wood is more resilient from rotting when submerged. The beams were secured together with galvanized nails and anchored to the stream bed using untreated rebar. To protect the opposite bank at this location a log jam was placed and anchored to prevent scouring from the discharge off the deflector. The purpose of the log crib deflector is to create a large pool using the force of high spring melt water, for fish to utilize in the warmer summer months when water levels drop and temperatures rise. The second location indicated by the yellow mark in figure 6 was a pinching deflector was placed, where two deflectors adjacent to one another creating a pool towards the center of a waterway. One deflector was built using the crib design, using 3-8ft 6x6 juniper beams and 3-8ft 6x6 beams connecting at a 90° angle, being keyed into the bank 3ft and anchored with rebar. The second deflector at this location was built using the wing deflector design, one single 7ft unprocessed log was anchored with rebar at a 30° angle from the bank. All crib deflectors were lined with filter fabric and spruce limbs to help protect the inside from erosion and then filled with 15 tons of grade 6 rocks between the 4 deflectors for stabilization. In addition, brush mats were placed along the banks up and down stream of the deflectors for added bank support and sediment control. This fish habitat restoration project was completed with the help of 3 neighbouring groups, Hunter-Clyde watershed group, Central Queens Wildlife Federation and the Bedeque Bay Environmental Management Association, shown in figure 7.

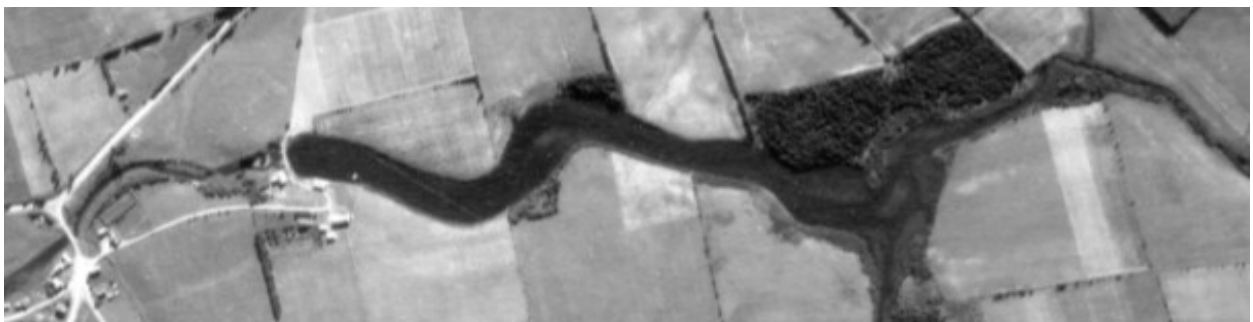
Figure 5: Aerial Photo of Rackham's Pond on the Wheatley River, 1935.

Rackham's pond was originally a large pond basin dating back to 1935, which can be seen in figure 5. Now in 2017 the pond is gradually returning to its original meander along the back portion, figure 6. This portion has very little cover for fish regarding vegetation overhead and pool areas, with excessive silt. Pool distance measurements were taken and using the data collected two log crib deflectors were built in this area, to provide the fish with better

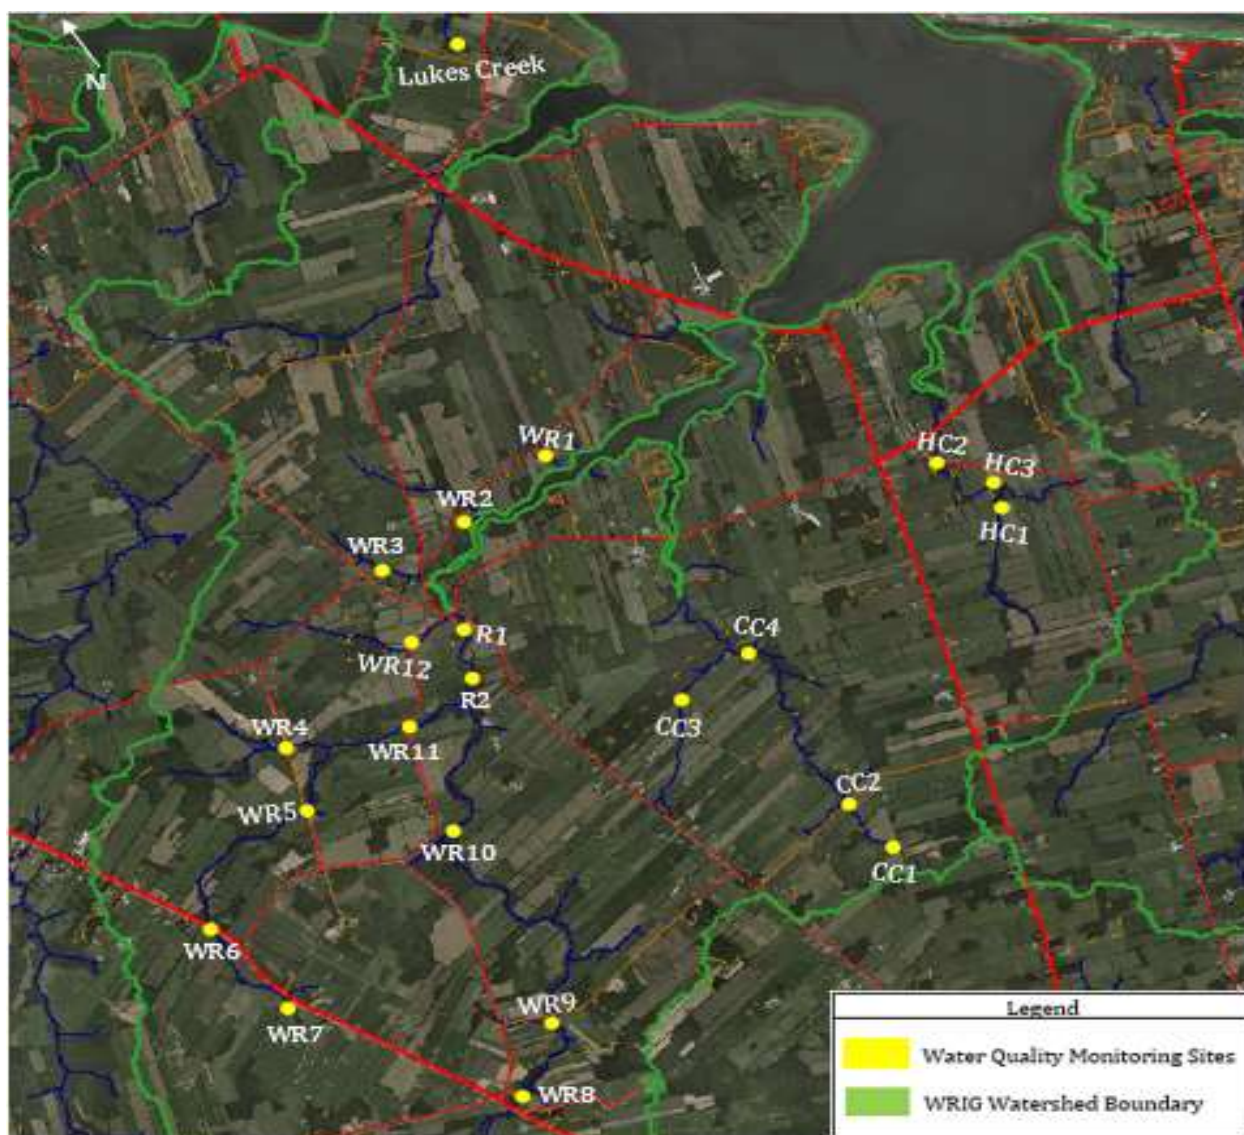
Figure 8: Locations of all Water Quality Monitoring Site Across the Wheatley River Watershed.

Water quality monitoring was performed every week on all the major tributaries in the Wheatley River watershed. WRIG shared a YSI water quality monitoring meter with the Hunter Clyde watershed group, that just recently had a nitrate probe installed. A total of 22 sites were monitored this year, as seen in figure 8 for temperature, dissolved oxygen, specific conductance, conductivity, total dissolved solids, salinity, pH and nitrates. Overall With the results collected form this sampling WRIG will have a better understanding of the quality of

water and habitat in the watershed, and be equipped to make informed management decisions. All results from this monitoring can be seen in appendix A.

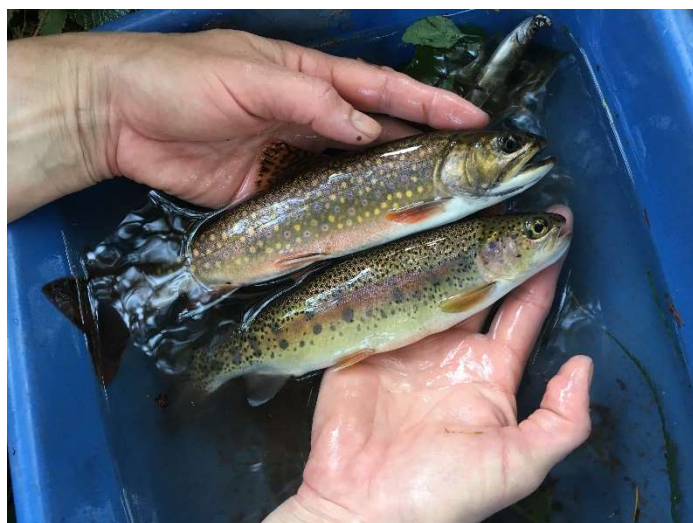
Figure 10: Comparison Between Rainbow Trout and Brook Trout Pulled from the Electrofishing Sampling Performed on August 14, 2017.

is performed to accumulate data for population and breeding estimates as well as species variety. A portion of the river is closed off using sen netting and all sampling is performed inside the barrier. Compared to samplings done in passed years this was the first-year Rainbow trout were collected in the sampling process. Rainbow trout are a non-native invasive species on PEI and were introduced via stocking and hatchery escapees. Rainbow trout are now present in over 20 rivers in Prince Edward Island including neighbouring

Hunter River, and now in the Wheatley River system also. Rainbow trout and Brook trout have conflicting hatching cycles, and Brook trout populations decline when Rainbows trout are present. Brook trout lay their eggs in the fall, to incubate over winter and hatch in the spring, Rainbow trout lay their eggs in the spring in the same habitat as Brook trout. Because

of this Rainbow trout have the potential to destroy native Brook trout nests and prey upon the fry that hatch.

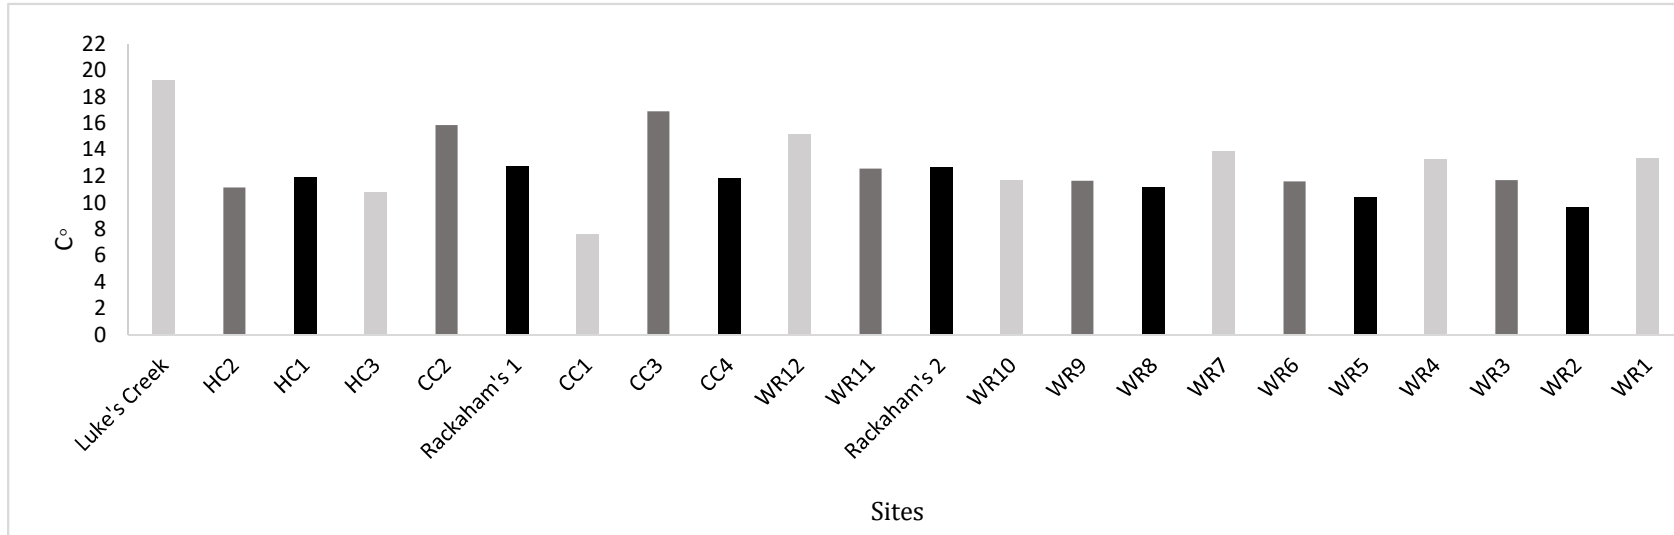
Figure A- 1: Average Temperature Across All Water Quality Monitoring Sites in the Wheatley River Watershed. Date Accumulated Using YSI Sampling Meter.

Figure A- 2: Average Dissolved Oxygen (DO) Across all Water Quality Monitoring Sites in the Wheatley River Watershed. Data Accumulated Using YSI Sampling Meter. Figure A- 3: Average Temperature Across All Water Quality Monitoring Sites in the Wheatley River Watershed. Date Accumulated Using YSI Sampling Meter.

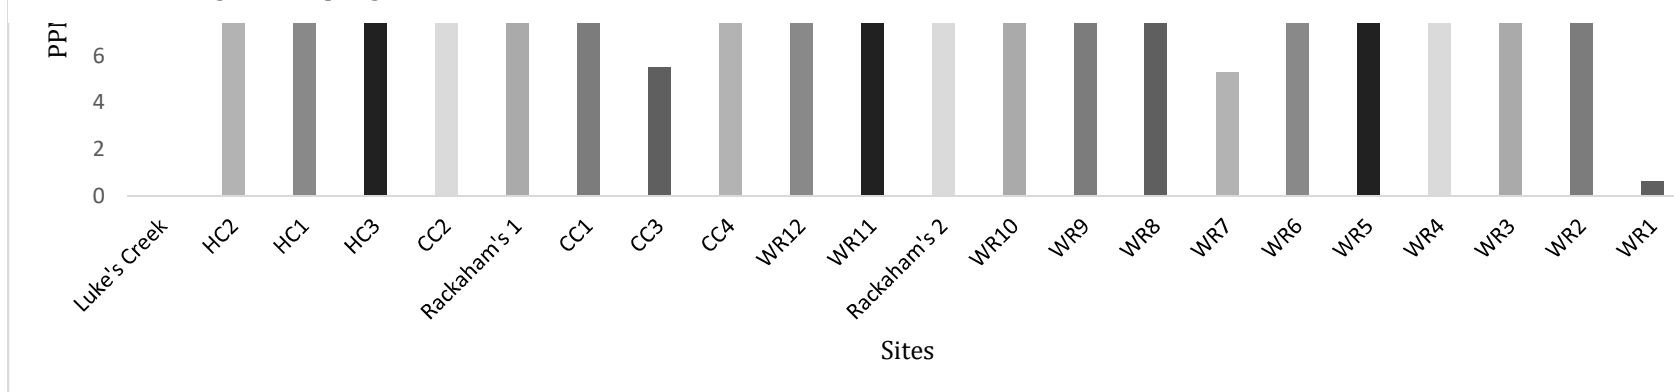
Figure A- 4: Average Dissolved Oxygen (DO) Across all Water Quality Monitoring Sites in the Wheatley River Watershed. Data Accumulated Using YSI Sampling Meter.

Figure A- 5: Average Conductivity (C) Across all Water Quality Monitoring Sites in the Wheatley River Watershed. Data Accumulated using YSI Sampling Meter.

Figure A- 6: Average Dissolved Oxygen (DO) Across all Water Quality Monitoring Sites in the Wheatley River Watershed. Data Accumulated Using YSI Sampling Meter.

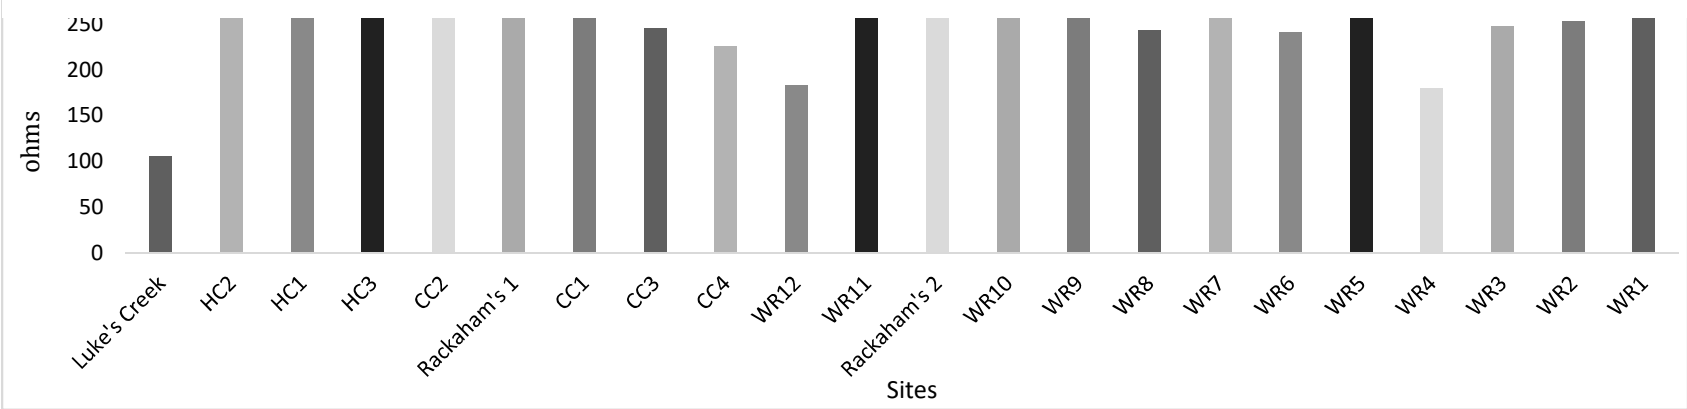
Figure A- 10: Average Specific Conductance (SPC) Across all Water Quality Monitoring Sites in the Wheatley River Watershed. Data Accumulated Using YSI Sampling Meter.

Figure A- 11: Average Total Dissolved Solids (TDS) Across all Water Quality Monitoring Sites in the Wheatley River Watershed. Data Accumulated using YSI Sampling Meter.

Figure A- 12: Average Specific Conductance (SPC) Across all Water Quality Monitoring Sites in the Wheatley River Watershed. Data Accumulated Using YSI Sampling Meter.

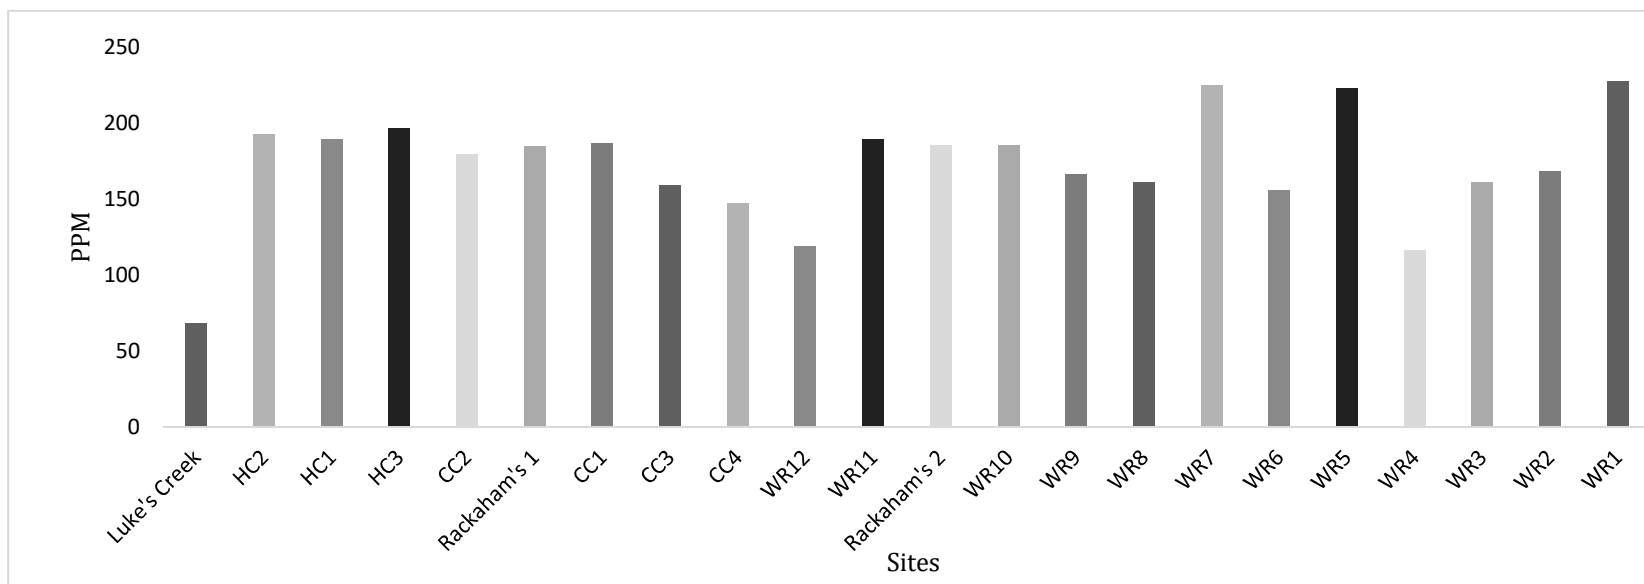
Figure A- 13: Average Total Dissolved Solids (TDS) Across all Water Quality Monitoring Sites in the Wheatley River Watershed. Data Accumulated using YSI Sampling Meter.

Figure A- 14: Average Salinity Across all Water Quality Monitoring Sites in the Wheatley River Watershed. Data Accumulated using YSI Sampling Meter. Figure A- 15: Average Total Dissolved Solids (TDS) Across all Water Quality Monitoring Sites in the Wheatley River Watershed. Data Accumulated using YSI Sampling Meter.

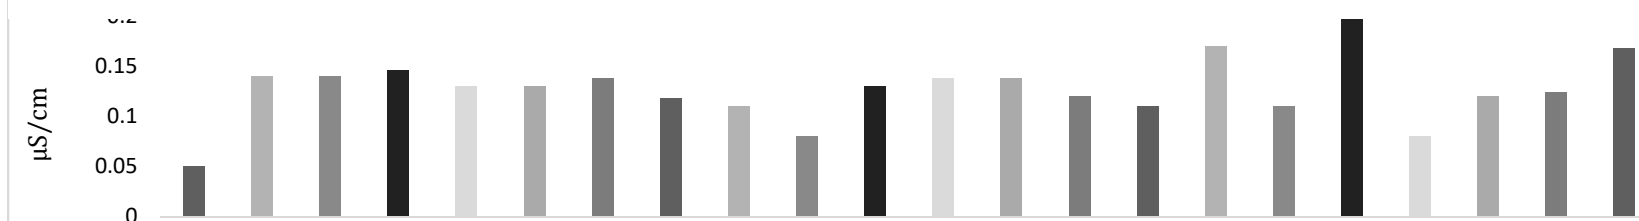
Figure A- 16: Average Salinity Across all Water Quality Monitoring Sites in the Wheatley River Watershed. Data Accumulated using YSI Sampling Meter.

Figure A- 17: Average pH Across all Water Quality Monitoring Sites in the Wheatley River Watershed. Data Accumulated using YSI Sampling Meter. Figure A- 18: Average Salinity Across all Water Quality Monitoring Sites in the Wheatley River Watershed. Data Accumulated using YSI Sampling Meter.

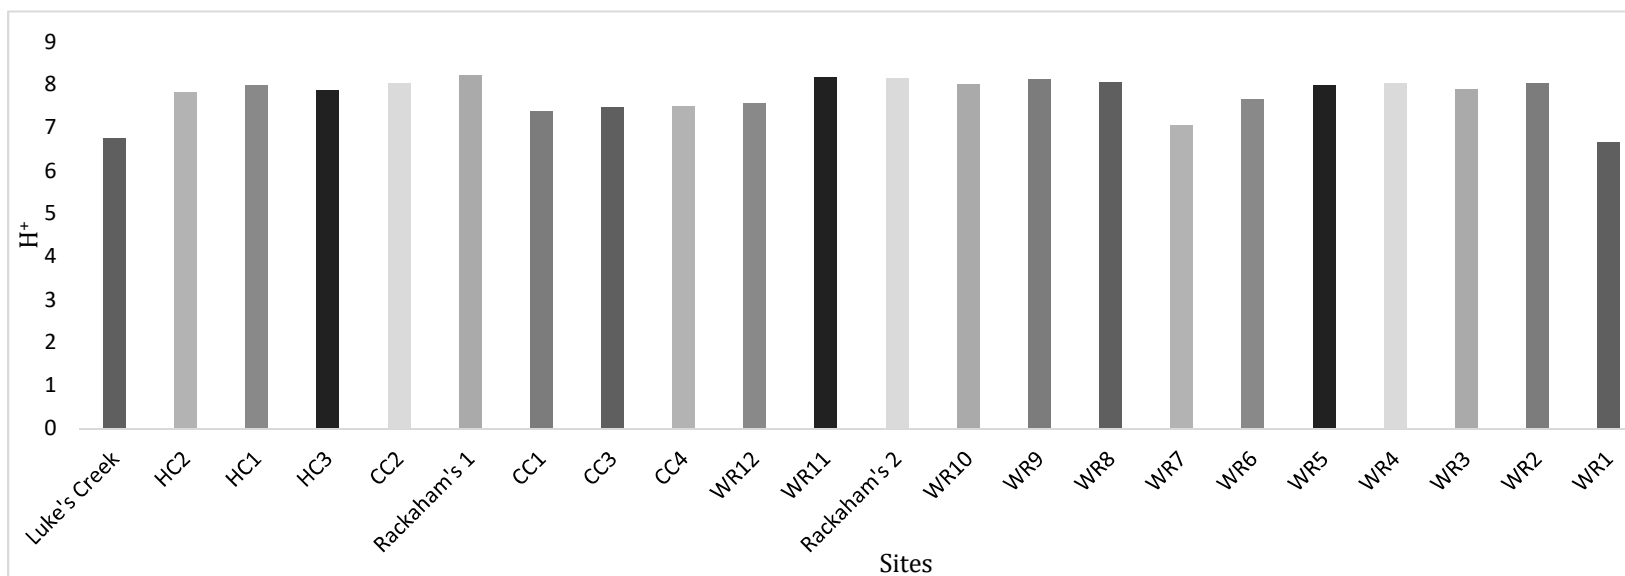
Figure A- 19: Average pH Across all Water Quality Monitoring Sites in the Wheatley River Watershed. Data Accumulated using YSI Sampling Meter.

Figure A- 20: Average Nitrate Levels (NO<sub>3</sub>-N) Across all Water Quality Monitoring Sites in the Wheatley River Watershed. Data Accumulated using YSI Sampling Meter. Figure A- 21: Average pH Across all Water Quality Monitoring Sites in the Wheatley River Watershed. Data Accumulated using YSI Sampling Meter.

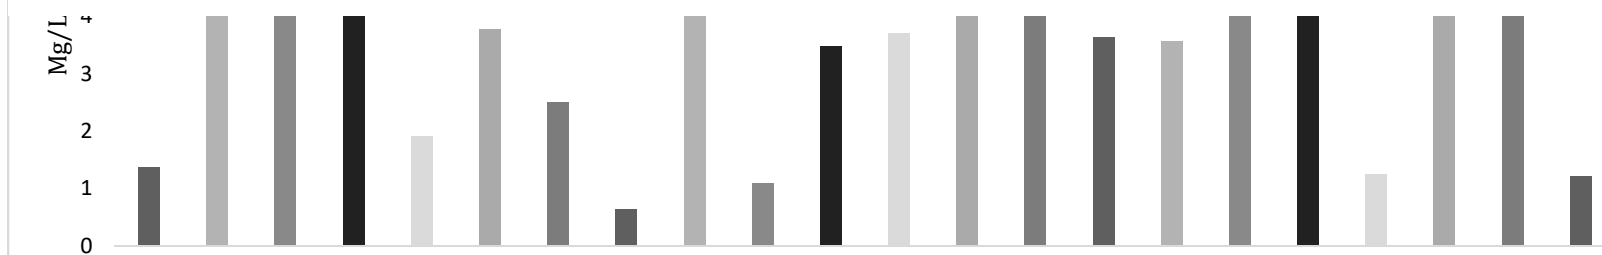
Figure A- 22: Average Nitrate Levels (NO<sub>3</sub>-N) Across all Water Quality Monitoring Sites in the Wheatley River Watershed. Data Accumulated using YSI Sampling Meter.
