WRIG

Field Crew Supervisor Report 2018

Hailey Blacquiere, Field Crew Supervisor

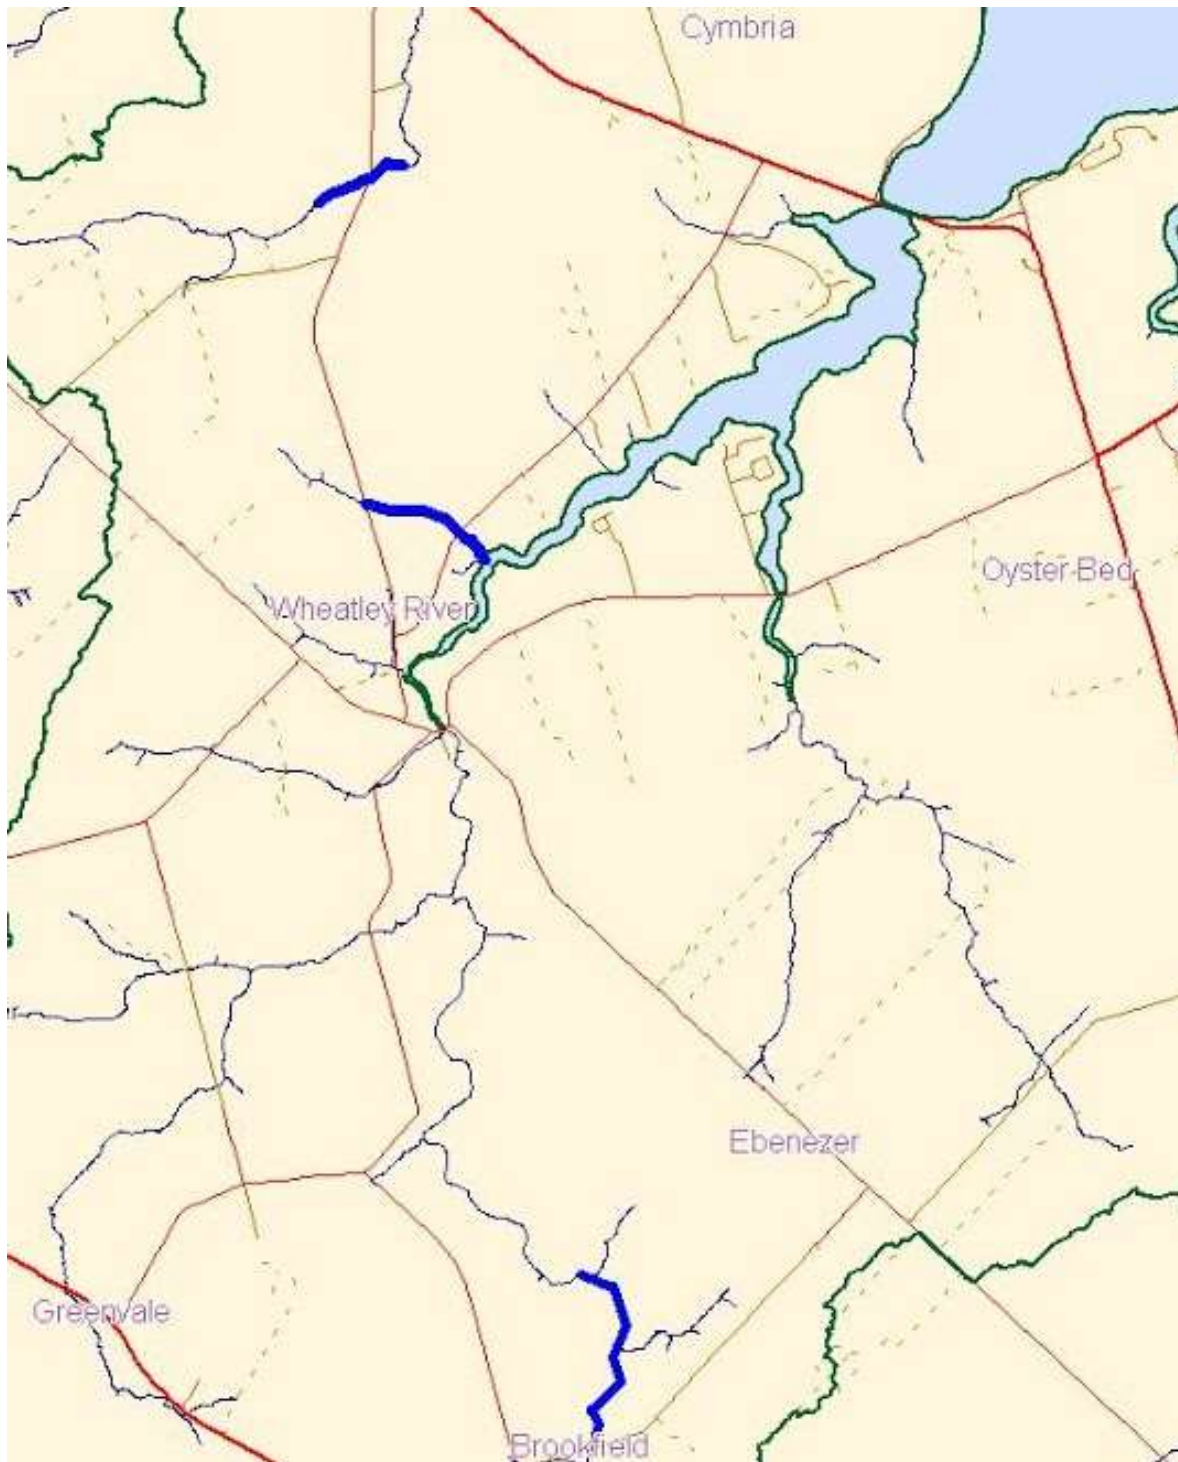
**Figure 2.** WRIG season 2018 stream cleared sections.

This year we have cleared a total of 3 km of stream. Clearing streams allows for better waterflow, sediment catch and oxygenation. As well one we are highly concerned about, fish passage! Portions of 3 major systems were restored this year, shown in **Figure 2**. The largest portion starting at Art Ford Cross road and continues downstream towards the many basin of the Wheatley River for 1.3 kilometres. This section was the most time consuming, as there were many large blockages as shown in the photos below. We cleared a number of these blockages with loppers and a Japanese's handsaw, this takes a lot of effort, especially in the heat. We were very excited when Hunter Clyde Watershed came to give us a hand with some of the larger blockages with chainsaws! The effort was still at a high and with 4 extra sets of hands we got more done which was fabulous.

The second location was a portion of Ross Creek in preparation for a special project that we had go on a landowner's property. We cleared this creek from the church road, all the way down to the main basin of the Wheatley River. This section was much more narrow then wide with only a few moderate blockages, most was debris that caught on small sticks. The area also has a good buffer zone through most of the section and contains a few sections of meadow grasses bordering fields. The Stead road runs across this section and the water quality monitoring point WR2 is also in on this section.

The final section of stream cleared was on Chapel Creek. We began going up stream roughly 400m which was pretty quick clearing as it was mainly grasses and on the sides of the bank with a few sections of alders that had to be trimmed back. The water way was quite deep but the sub straight was mainly compacted sediment and in the pools softer sediment. This section also had a trail system put in by the property owners including a small crossing. Noticed earlier in the summer A fisherman was storing lobster traps in the stream, which is not acceptable, but we did not get a chance to chat with them and the traps were removed the day after we began clearing in this section. To finish off our required amount of clearing we cleared the down stream side roughly 230m. This area is packed with bittersweet night shade, as well as some stinging nettle and blackberries. Once roughly 150m off the road the area opened up to a much more wooded section with some alders and a few downed trees.

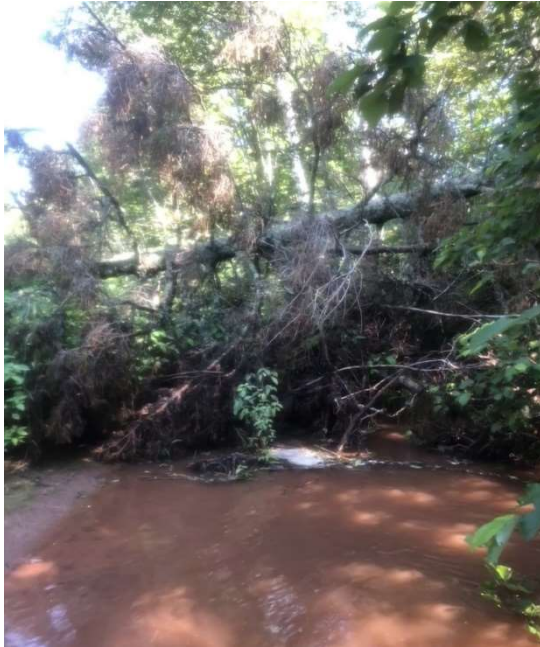
**Figure 3.** “Before” photo of a large blockage.

**Figures 3 and 4** show a before and after photo set of a large blockage that we cleared. A blockage of this size takes the crew roughly a 1-2 hours using hand tools such as loppers and a Japanese handsaw.

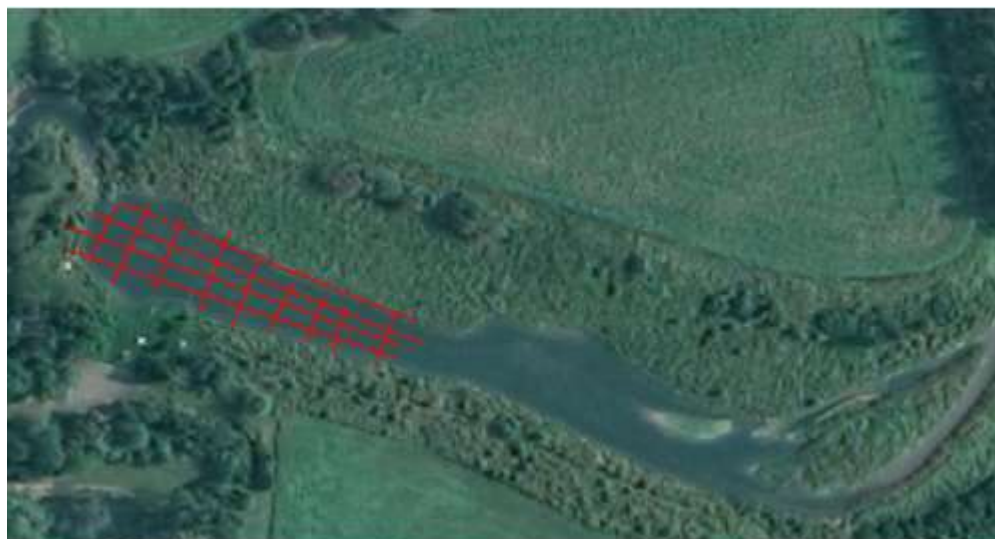
**Figure 5.** Rackham's Pond depth survey model.

This year we reconducted a depth survey of Rackham's pond. This will allow us to see how much sediment is gathering in the pond over the time since it was last dredged out. To conduct this survey we measured out 20 meter sections on the side of the bank starting at the dock structure. This would mark the beginning of each transect. In total we had 9 transects. Going across the pond (following the transect) we took measurements at the 5 meters from the bank 10m, 15m, 20m and 25m at the widest point. Below is a diagram (**Figure 5**) and a table (**Table 2**) containing the results. This diagram is very rough as digitally imported line don't match the lands contours but the concept should be clear, 9 transects going to the far side of the pond and measurements at 5-25m going across or where the line interest.

Lengths	Transect 1	Transect 2	Transect 3	Transect 4	Transect 5	Transect 6	Transect 7	Transect 8	Transect 9
5m	1m25cm	59cm	35cm	44cm	66cm	54cm	67cm	75.5cm	69cm
10m	1m60cm	44.5cm	54.5cm	88.5cm	1m21cm	24cm	36.5cm	30.5cm	
15m	59cm	43cm	81.5cm				70.5cm	70.5cm	
20m	71cm	43.5cm							
25m	48.5cm

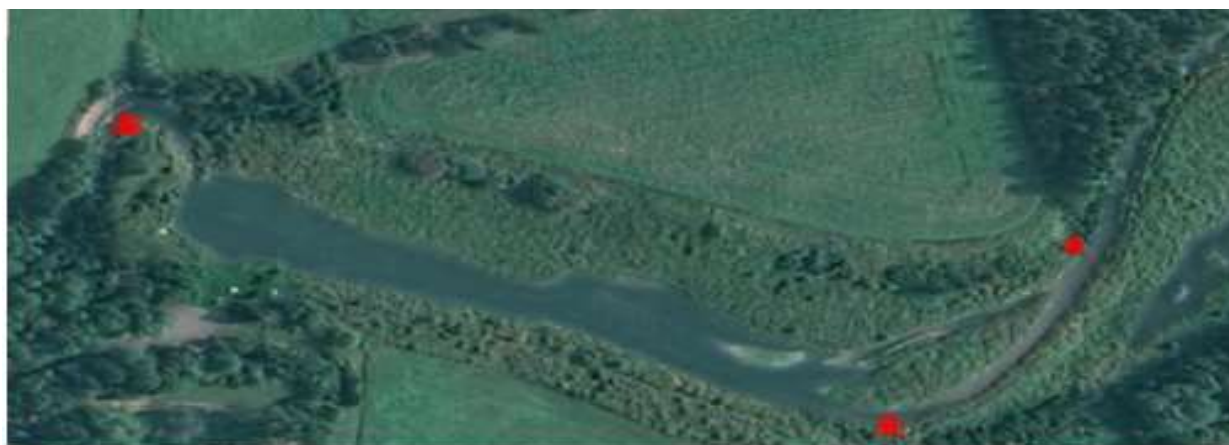
**Figure 6.** Macroinvertebrate sampling areas along Rackham's Pond on the Wheatley River. One Hester-Dendy sampler was placed in each of the locations shown.

in **Figure 6**, using a multi-plate Hester-Dendy sampler. Hester-Dendy's provide an opportunity for the invertebrates to colonize the sampler, and later be examined. The Hester-Dendy's were anchored to the bottom of the stream bed with rocks but not in direct contact with the substrate, with the plates parallel to water flow. The sampling took place for 3 weeks. Unfortunately we lost a Hester Dendy in the sediment at location 3 and were unable to locate it. Samplers 1 and 2 were both successful homes for the macroinvertebrates and in the following tables is a list of species found.

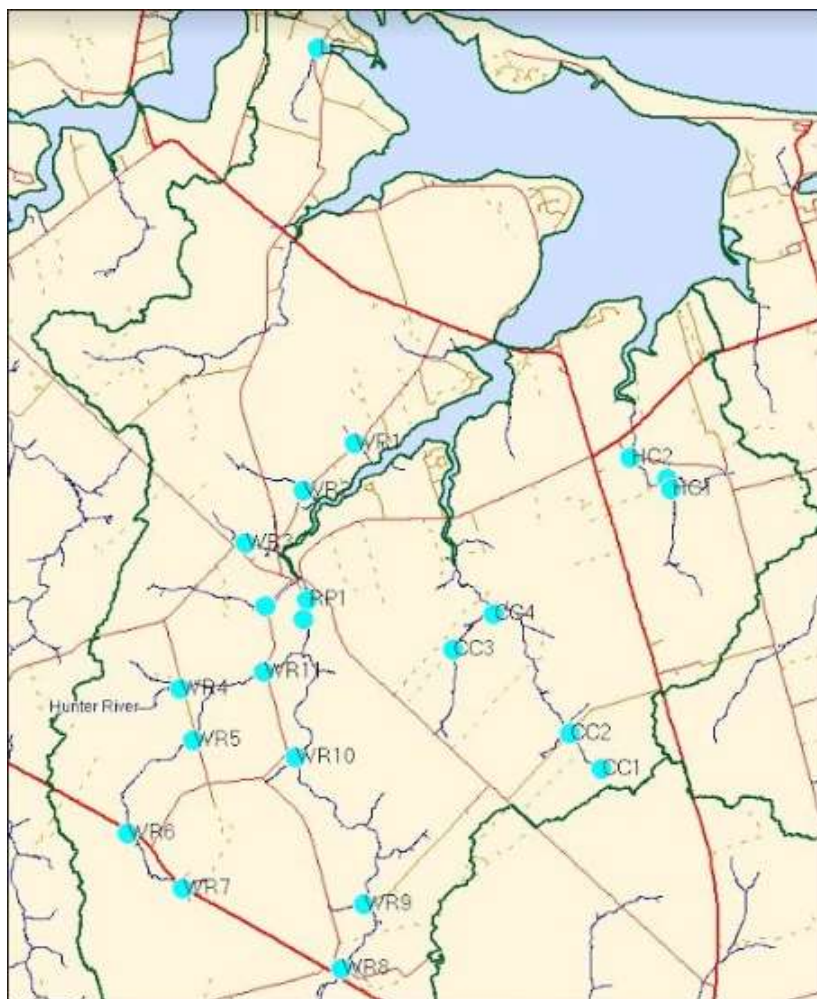
**Figure 7.** Locations of all Water Quality Monitoring Sites across the Wheatley River Watershed.

Water quality monitoring was a weekly task that the crew performed on all the major tributaries in the Wheatley River watershed. WRIG shared a YSI water quality monitoring meter with the Hunter Clyde watershed group (HCWG). A total of 22 sites were monitored this year, as seen in **Figure 7** for temperature, dissolved oxygen, specific conductance, conductivity, total dissolved solids, salinity, pH and nitrates. The results collected from this sampling allow WRIG a better understanding of the quality of water and habitat in the watershed, which in turn equips us with better info which gives us better informed management decisions. All results from this monitoring can be seen in **Appendix A**.

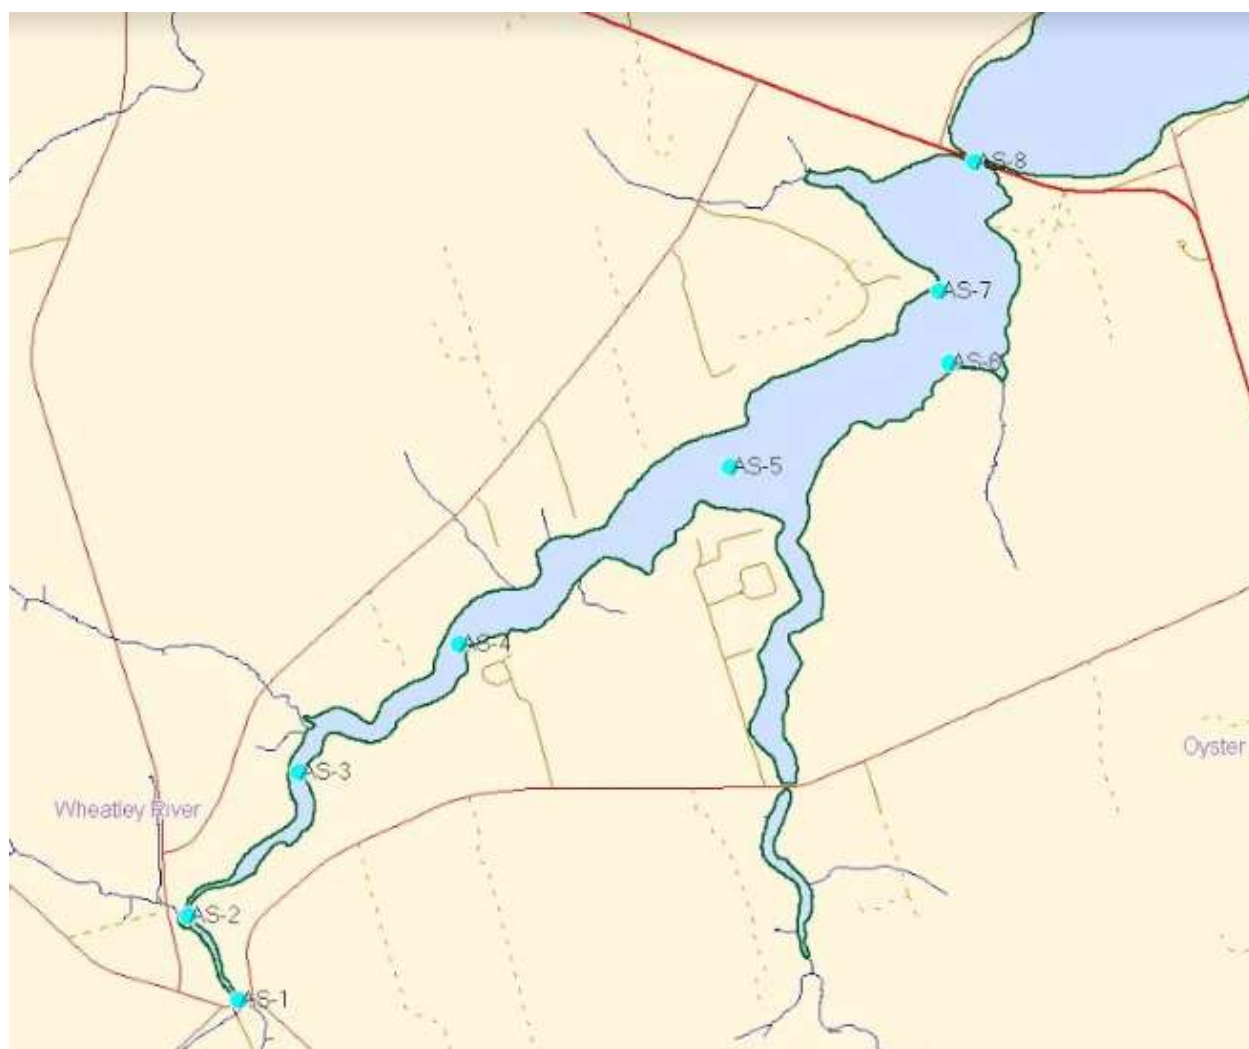
**Figure 8.** WRIG Canoe Anoxia survey locations.

Once a month the crew canoed from the Wheatley river bridge to the Oyster Bed Bridge, along this stretch 8 points were monitored (**Figure 8**) for temperature, dissolved oxygen, specific conductance, conductivity, total dissolved solids, salinity, pH as well as the colour of the water, clarity, if there was any odour and the health of the sea lettuce. We had many extremely hot days this summer with 40+ degree weather, it was surprising that the sea lettuce although bad in the end of July into the first week of August was present, the intense smell did not seem too persist as long, as it had in previous years.

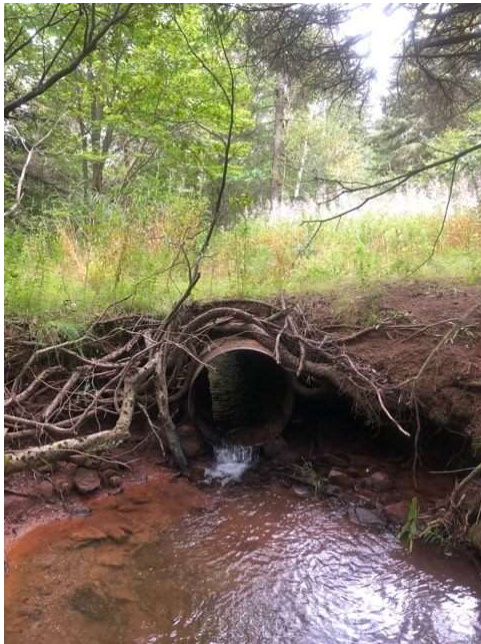
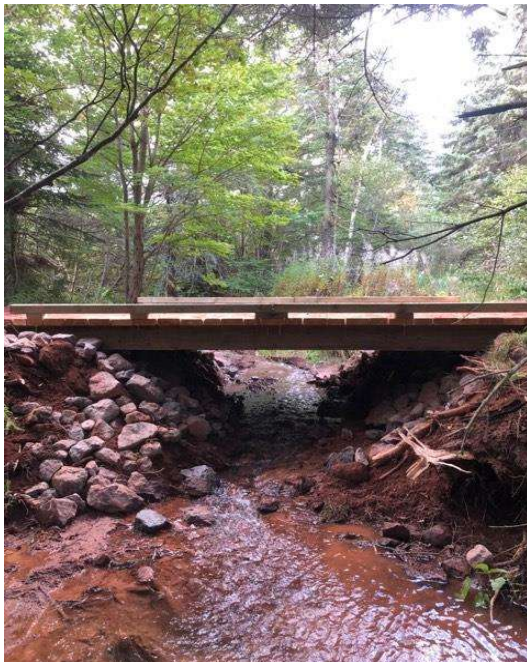
**Figure 9.** Jack's Bridge "before" and "after" photos.

A very exciting project! Although we didn't help much with the large equipment and building we were excited watch as an old damaged culvert was converted into a beautiful and safe stream crossing, for the property owners and the ATVs that use the trail system. Not only does this crossing help in human transport but also our fish! The damaged culvert would have been terribly difficult to navigate. Now a lovely peddle bottom channel should allow excellent conditions for migrating fish. Pictured below is an astonishing before and after photo.

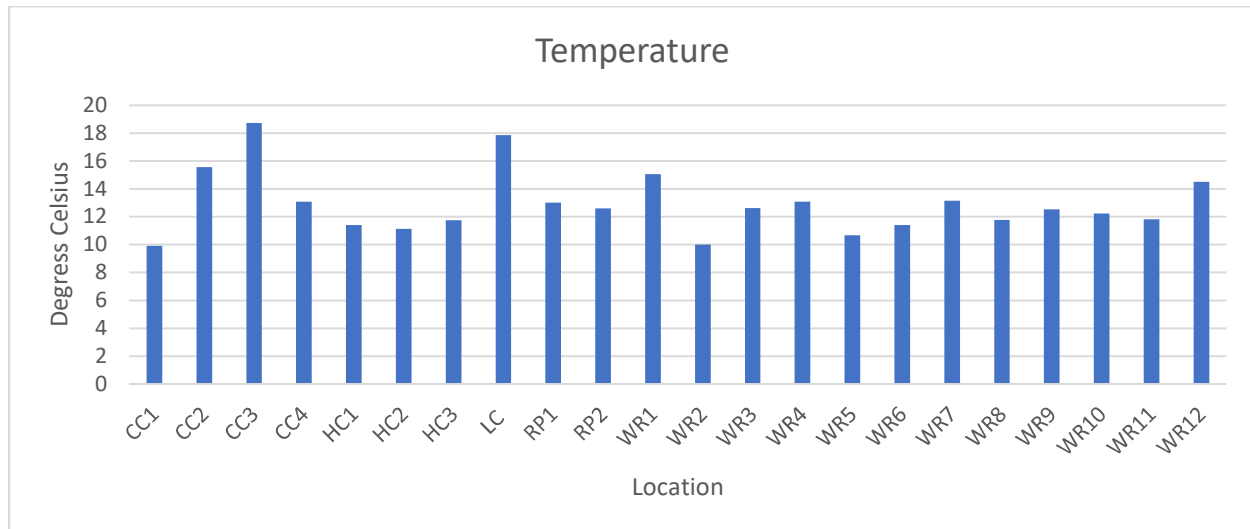
**Figure A-1: Average Temperature across All Water Quality Monitoring Sites in the Wheatley River Watershed. Data accumulated using YSI Sampling Meter.**

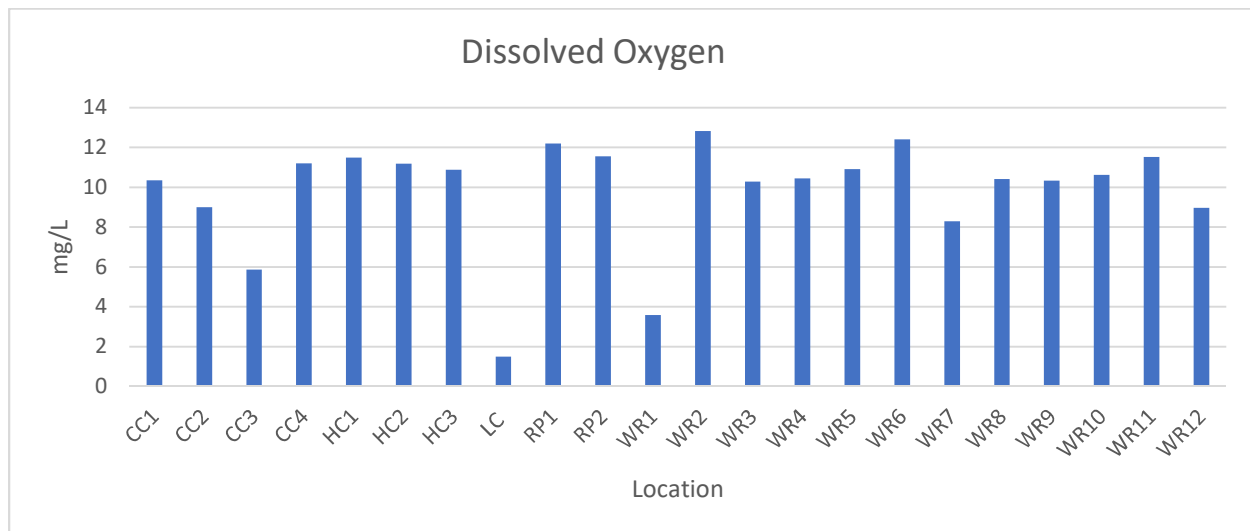
**Figure A- 2: Average Dissolved Oxygen (DO) across all Water Quality Monitoring Sites in the Wheatley River Watershed. Data accumulated using YSI Sampling Meter.**

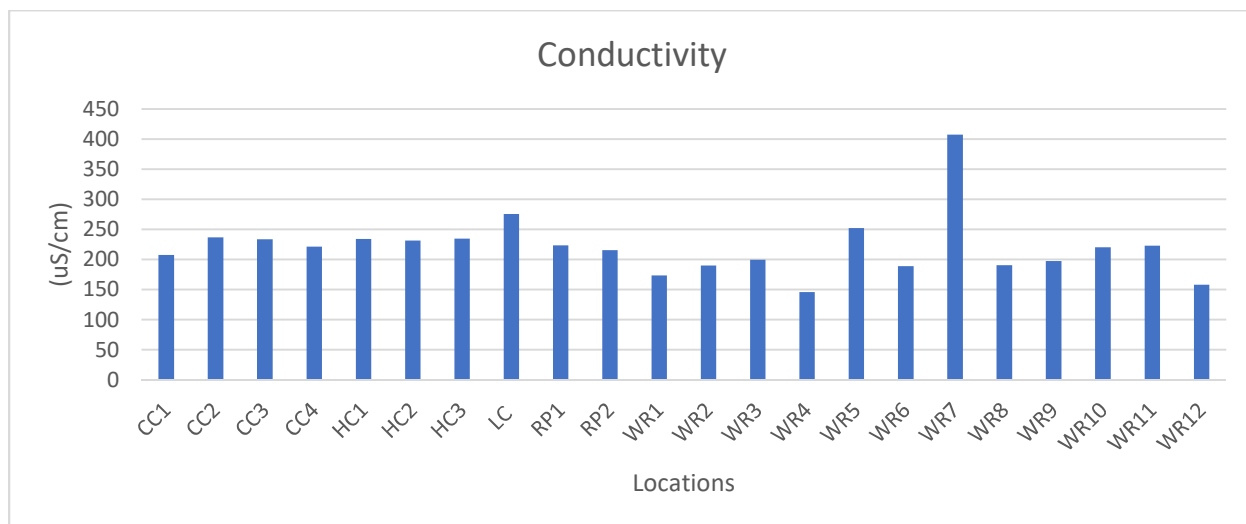
**Figure A- 3: Average Conductivity (C) across all Water Quality Monitoring Sites in the Wheatley River Watershed. Data accumulated using YSI Sampling Meter.**

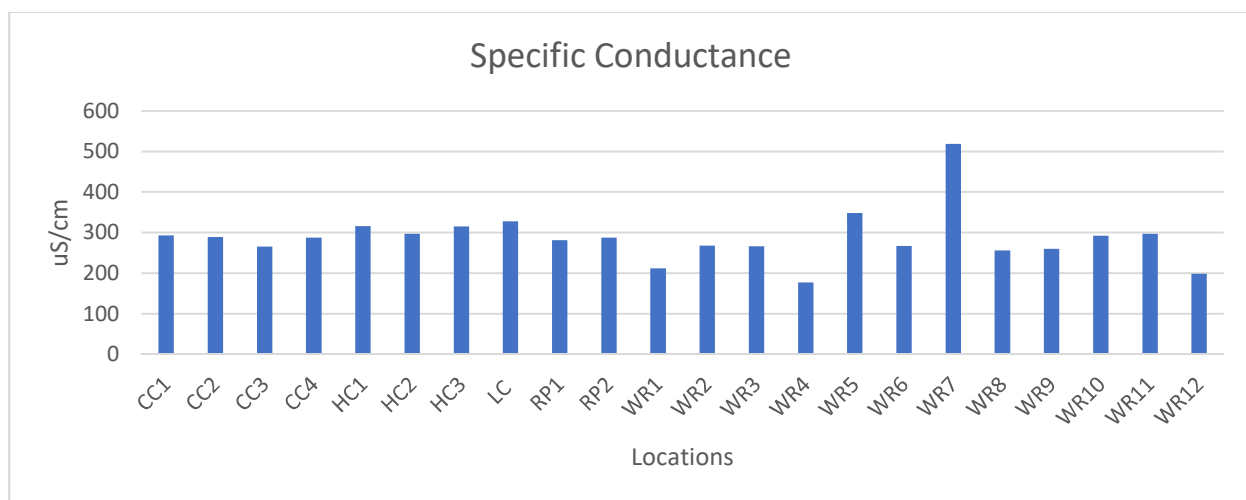
**Figure A- 4: Average Specific Conductance (SPC) across all Water Quality Monitoring Sites in the Wheatley River Watershed. Data accumulated using YSI Sampling Meter.**

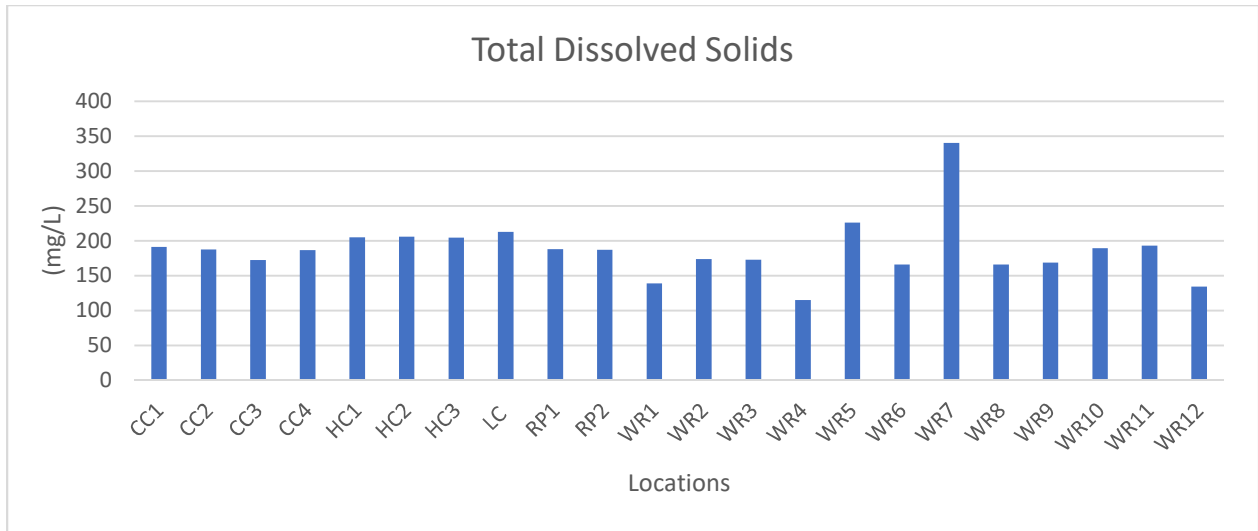
**Figure A- 5: Average Total Dissolved Solids (TDS) across all Water Quality Monitoring Sites in the Wheatley River Watershed. Data accumulated using YSI Sampling Meter.**

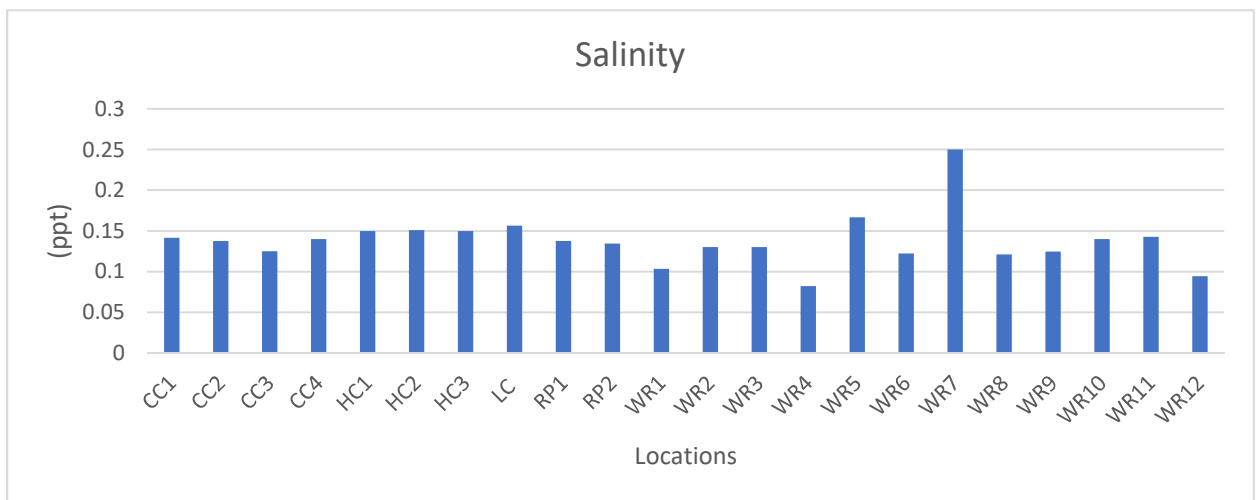
**Figure A- 6: Average Salinity across all Water Quality Monitoring Sites in the Wheatley River Watershed. Data accumulated using YSI Sampling Meter.**

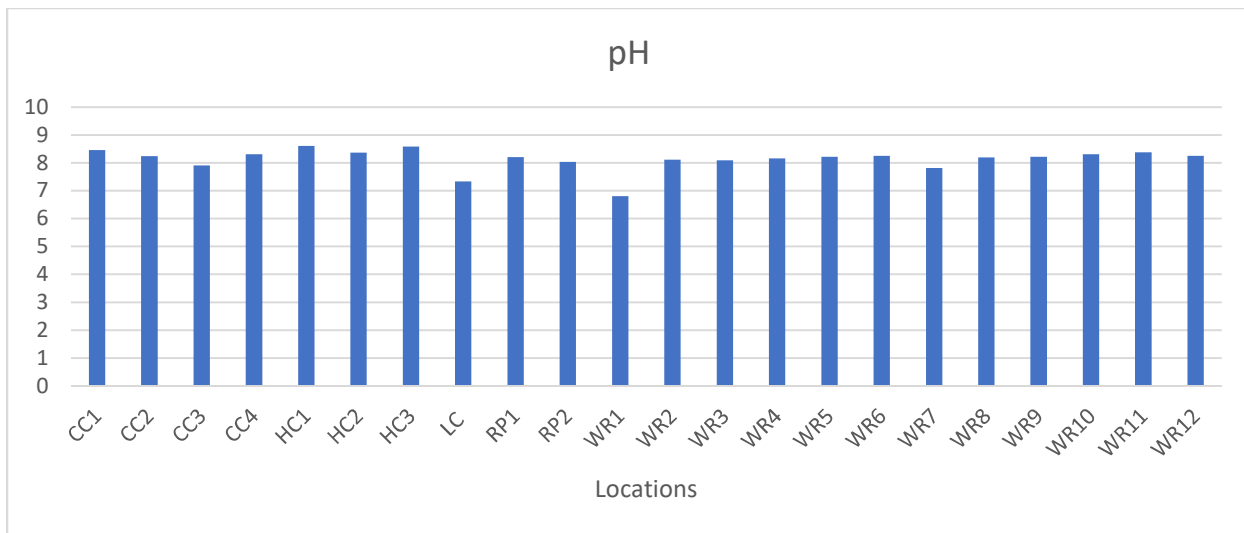
**Figure A- 7: Average pH across all Water Quality Monitoring Sites in the Wheatley River Watershed. Data accumulated using YSI Sampling Meter.**

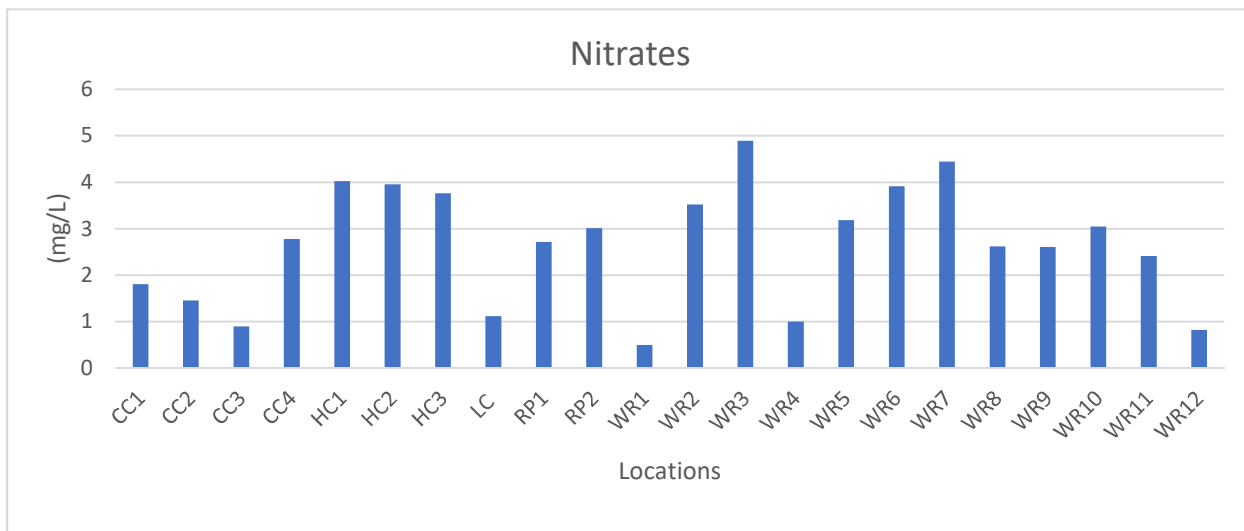
**Figure A- 8: Average Nitrate Levels (NO<sub>3</sub>-N) across all Water Quality Monitoring Sites in the Wheatley River Watershed. Data accumulated using YSI Sampling Meter.**
