WRIG FIELD CREW SUPERVISORS REPORT

Summer 2013

Prepared for the Wheatley River Improvement Group

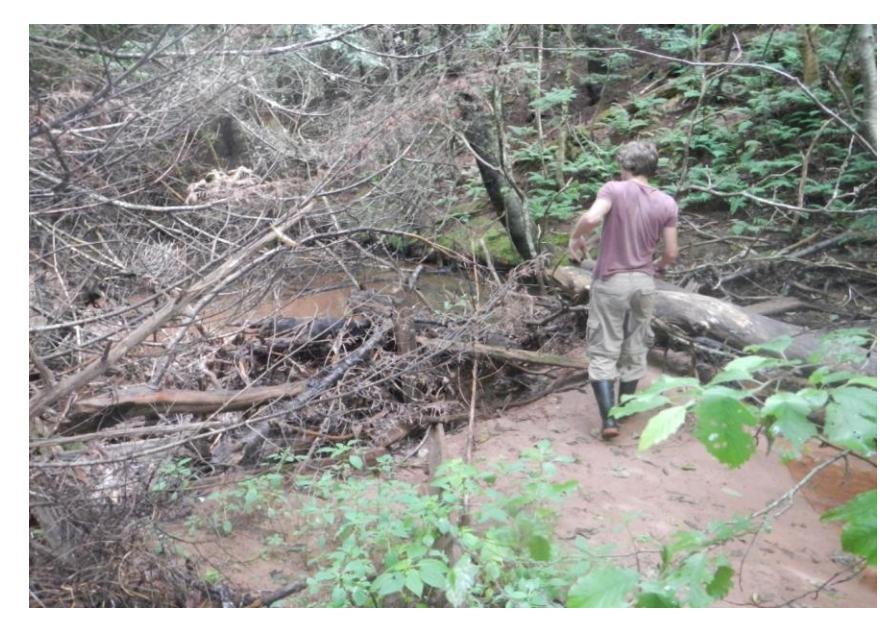
Figure 2. Collin Jeffrey assessing a blockage on the Wheatley River.

The Wheatley River was our biggest project this summer. We began working from the Art Ford Cross Road and completed work from there to Old Route 2 and then Route 2. We have also completed from Rackham's Pond all the way to the Art Ford Cross Road. We have removed dozens of large, fish impeding blockages and we are proud to say fish passage is now possible

from the estuary all the way past Route 2. We have also cleared out the tributary off the Wheatley that leads to the Little Bungay Road. This section was in need of major work as old spruce trees had this stream severely blocked at many locations. We were able to clear the worst of this area and restore fish passage but a chainsaw will be required at some point to cut some large trees out and prevent future blockages.

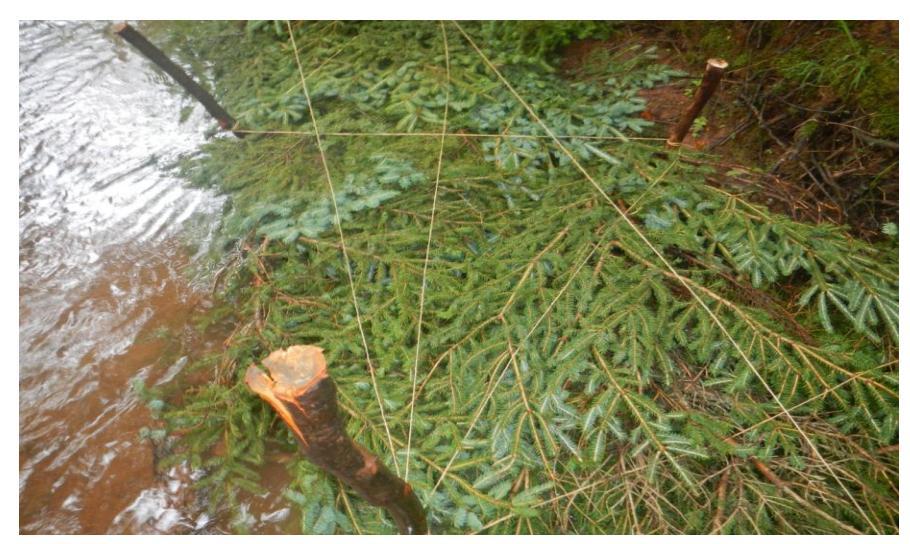
removed some old mats Figure 3. A section of brush mat along the Wheatley River.

with changing stream conditions (mats located in middle of stream blocking flow with stakes

and twine). We installed over a dozen brush mats this year. We focused our efforts on the Wheatley River where we installed and refilled 10 brush mats. We installed many below the Art Ford Cross section and several above here. We also installed one by the Parker Cross section of Crooked Creek and several others on the main branch of the Wheatley River.

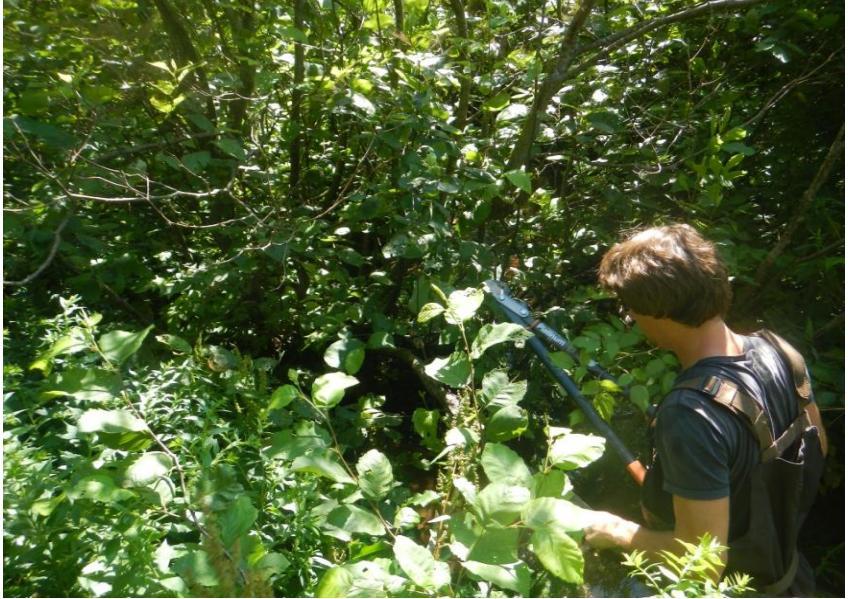
Figure 4. Collin Jeffrey clearing alders on Chapel Creek

creating blockages. We spent a lot of time thinning these sections so that the alders still provide shade but are completed removed from the water and immediately above the water. This ensures they will not create blockages in future spring flows but still function to provide cover for fish. We removed alders from a large section on

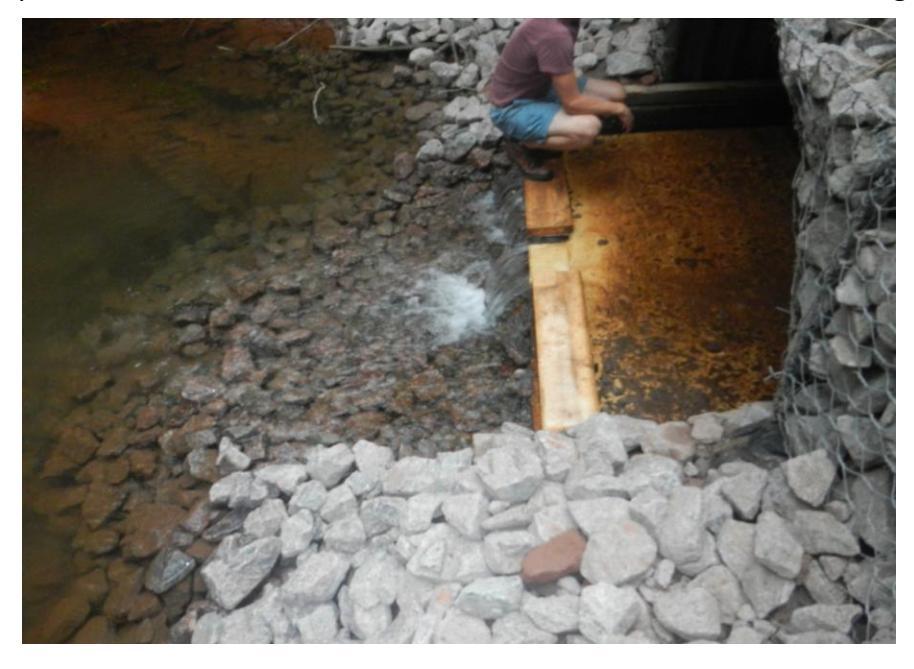
Culverts, bridges and road crossing are major sources of fish passage problems all over the province and we have several severe issues in our watershed. Hung culverts are a barrier to all

but the largest fish and we have numerous of these located throughout the watershed. lt is important to work with transportation and landowners to remove problem culverts and ensure new ones are installed properly. Debris also has a habit of collecting at bridges and road crossing. We went around the watershed this summer and cleared

Figure 5. A culvert that iscausing fish passage problems on the Little Bungay Road.

out our culverts and small bridges that had been blocked up with wood and debris and this will need to be continued in future years.

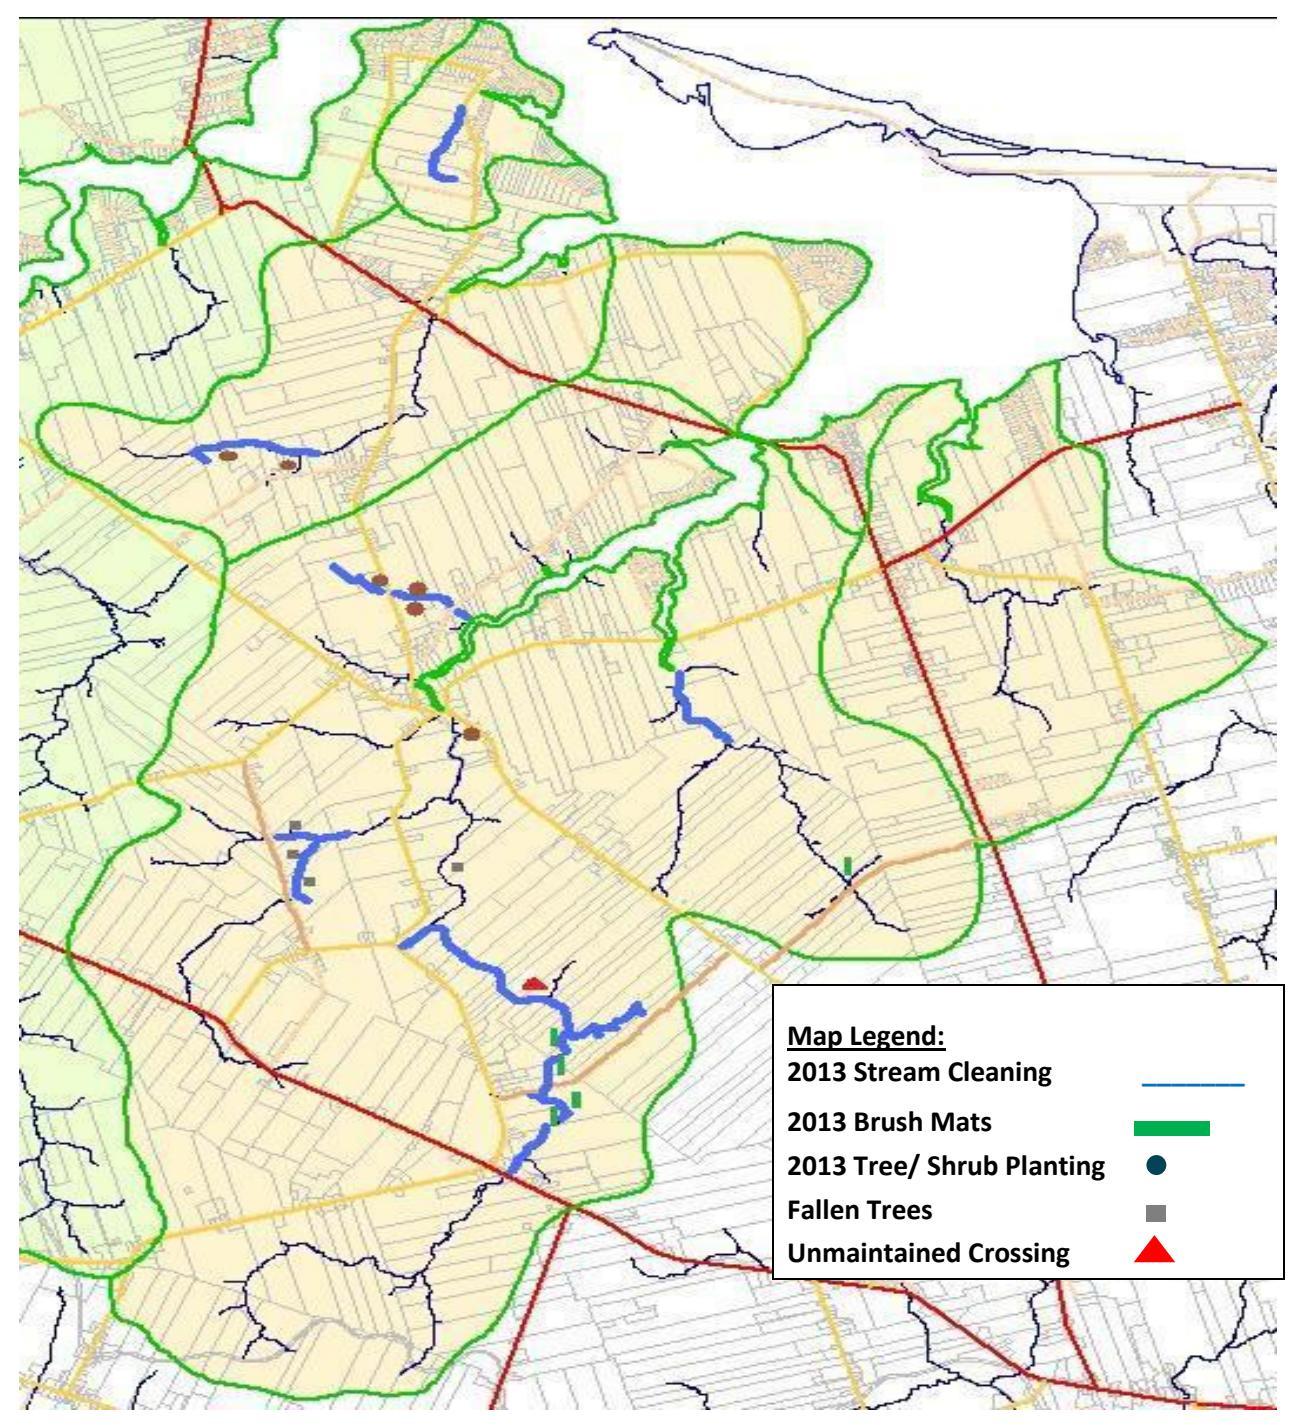
Figure 9 Map of Wheatley River and surrounding Watersheds, indicating locations of Stream restoration and tree planting locations 2013.
